Access Compliance Report

Public Rights-of-Way

(Island Curb Cuts)

| Intersection ID: 10029218 | Main Street: JOHNSON AND WALES_WY | Cross Street: N/A | Location: N |

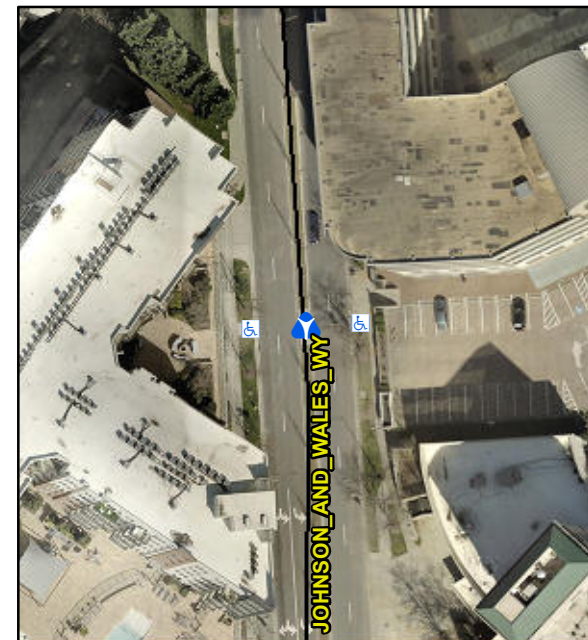
| ADA ID: 1F0AD2B08013 | Curb Cut Type: MedianRefuge2 | Initial Pass/Fail: Fail | Overall Compliance: No |

| Compliance | Description | Data | Compliance | Description | Data |
|---|---|---|---|---|---|
| No | Refuge 1 Length (In) | 30.0 | N/A | Gutter 1 Ponding? | N/A |
| No | Refuge 2 Length (In) | 30.0 | N/A | Gutter 2 Ponding? | N/A |
| No | Refuge 2 X Slope (%) | 6.0 | N/A | Gutter 2 X Slope (%) | N/A |

Remove & Replace Entire Refuge.

\$ 3000.00
