Access Compliance Report

Public Rights-of-Way

(Island Curb Cuts)

Intersection ID: 52494	Main Street: WEST_BV	Cross Street: NEW_RENAISSANCE_WY	Location: NE
ADA ID: 1FBDAE4EF379	Curb Cut Type: MedianRefuge2	Initial Pass/Fail: Fail	Overall Compliance: No
Severity Score: 1.25			
Codes/Mitigation Info/Possible Solution		Field Measurements/Component Compliance

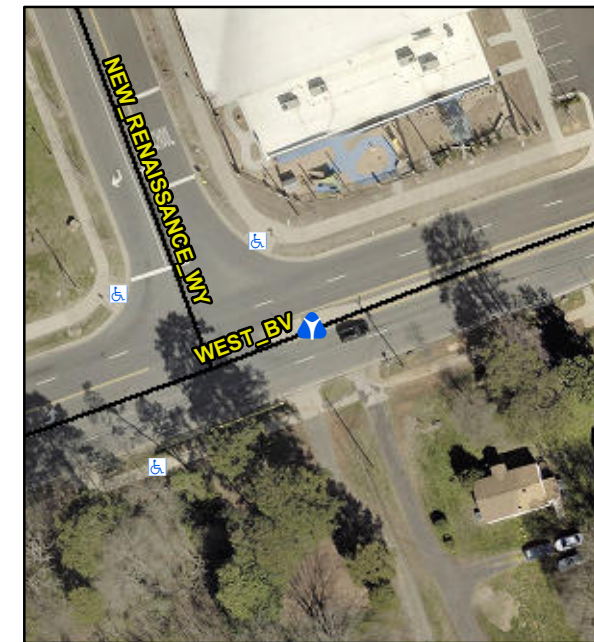
Compliance	Description	Data	Compliance	Description	Data
Yes	Refuge 1 Length (In)	60.0	N/A	Gutter 1 Ponding?	N/A
Yes	Refuge 1 Width (In)	72.0	N/A	Gutter 1 Lip Ht (In)	N/A
Yes	Refuge 1 Slope (%)	2.6	N/A	Gutter 1 Slope (%)	N/A
Yes	Refuge 1 X Slope (%)	3.6	N/A	Gutter 1 X Slope (%)	N/A
N/A	Painted X Walk1?	No	N/A	DWS 1 Provided?	N/A
N/A	X Walk 1 Direction	To NW	N/A	DWS 1 Contrast?	N/A
N/A	X Walk 1 Width (In)	N/A	N/A	DWS 1 Length (In)	N/A
N/A	Road 1 Slope (%)	3.3	N/A	DWS 1 Full Width?	N/A
N/A	Road 1 X Slope (%)	3.1	N/A	DWS 1 Offset (In)	N/A
Yes	Refuge 2 Length (In)	60.0	N/A	Gutter 2 Ponding?	N/A
Yes	Refuge 2 Width (In)	72.0	N/A	Gutter 2 Lip Ht (In)	N/A
Yes	Refuge 2 Slope (%)	1.7	N/A	Gutter 2 Slope (%)	N/A
Yes	Refuge 2 X Slope (%)	3.7	N/A	Gutter 2 X Slope (%)	N/A
N/A	Painted X Walk2?	No	N/A	DWS 2 Provided?	N/A
N/A	X Walk 2 Direction	To SE	N/A	DWS 2 Contrast?	N/A
N/A	X Walk 2 Width (In)	N/A	N/A	DWS 2 Length (In)	N/A

N/A	Road 2 Slope (%)	2.4	N/A	DWS 2 Full Width?	N/A
N/A	Road 2 X Slope (%)	2.6	N/A	DWS 2 Offset (In)	N/A
N/A	Refuge 3 Length (in)	N/A	N/A	Gutter 3 Ponding?	N/A
N/A	Refuge 3 Width (in)	N/A	N/A	Gutter 3 Lip Ht (in)	N/A
N/A	Refuge 3 Slope (%)	N/A	N/A	Gutter 3 Slope (%)	N/A
N/A	Refuge 3 XSlope (%)	N/A	N/A	Gutter 3 XSlope (%)	N/A
N/A	Painted X Walk3?	N/A	N/A	DWS 3 Provided?	N/A
N/A	X Walk 3 Direction	N/A	N/A	DWS 3 Contrast?	N/A
N/A	X Walk 3 Width (in)	N/A	N/A	DWS 3 Length (in)	N/A
N/A	Road 3 Slope (%)	N/A	N/A	DWS 3 Full Width?	N/A
N/A	Road 3 XSlope (%)	N/A	N/A	DWS 3 Offset (in)	N/A
Yes	Any Obstructions?	N/A	N/A	Storm Grate/Utility Hazard?	N/A
N/A	Obstruction Type		N/A	Storm Grate/Utility Type	
		N/A			N/A
N/A	Surface Condition	Good

Possible Solutions:

Remove & Replace Entire Refuge.

Total Cost: \$ 3000.00
