Access Compliance Report

Public Rights-of-Way

(Island Curb Cuts)

Intersection ID: 7031	Main Street: BROOKSHIRE_BV	Cross Street: OAKDALE_RD	Location: NE
ADA ID: 216FE7809379	Curb Cut Type: MedianRefuge2	Initial Pass/Fail: Fail	Overall Compliance: No
Codes/Mitigation Info/Possible Solution		Field Measurements/Component Compliance	
Severity Score: 0

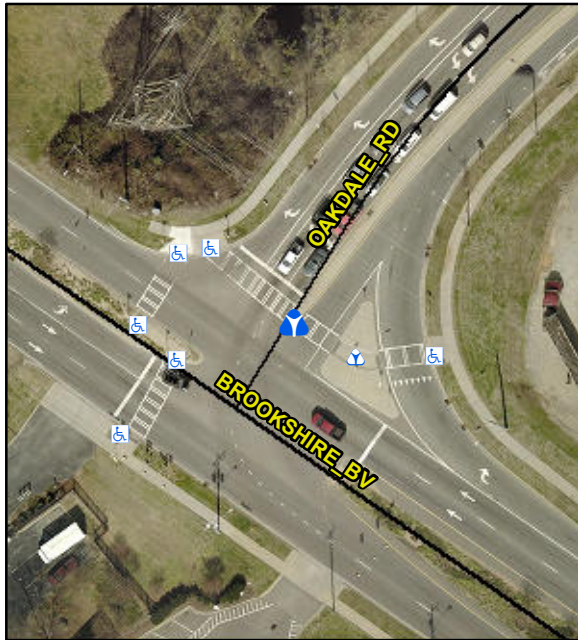
Compliance	Description	Data	Compliance	Description	Data
No	Refuge 1 Length (In)	25.0	N/A	Gutter 1 Ponding?	N/A
Yes	Refuge 1 Width (In)	96.0	N/A	Gutter 1 Lip Ht (In)	N/A
Yes	Refuge 1 Slope (%)	0.9	N/A	Gutter 1 Slope (%)	N/A
Yes	Refuge 1 X Slope (%)	2.6	N/A	Gutter 1 X Slope (%)	N/A
N/A	Painted X Walk1?	Yes	N/A	DWS 1 Provided?	N/A
N/A	X Walk 1 Direction	To SE	N/A	DWS 1 Contrast?	N/A
N/A	X Walk 1 Width (In)	111.0	N/A	DWS 1 Length (In)	N/A
N/A	Road 1 Slope (%)	1.7	N/A	DWS 1 Full Width?	N/A
N/A	Road 1 X Slope (%)	1.2	N/A	DWS 1 Offset (In)	N/A
No	Refuge 2 Length (In)	25.0	N/A	Gutter 2 Ponding?	N/A
Yes	Refuge 2 Width (In)	96.0	N/A	Gutter 2 Lip Ht (In)	N/A
Yes	Refuge 2 Slope (%)	0.4	N/A	Gutter 2 Slope (%)	N/A
Yes	Refuge 2 X Slope (%)	1.6	N/A	Gutter 2 X Slope (%)	N/A
N/A	Painted X Walk2?	Yes	N/A	DWS 2 Provided?	N/A
N/A	X Walk 2 Direction	To NW	N/A	DWS 2 Contrast?	N/A
N/A	X Walk 2 Width (In)	113.0	N/A	DWS 2 Length (In)	N/A

Remove & Replace Entire Refuge.
