Access Compliance Report

Public Rights-of-Way

(Island Curb Cuts)

Intersection ID: 6102	Main Street: UNIVERSITY_CITY_BV	Cross Street: UNIVERSITY_PROFESSIONAL_DR	Location: W
ADA ID: 218D6FF2FAE1	Curb Cut Type: MedianRefuge2	Initial Pass/Fail: Pass	Overall Compliance: No
Codes/Mitigation Info/Possible Solution		Field Measurements/Component Compliance

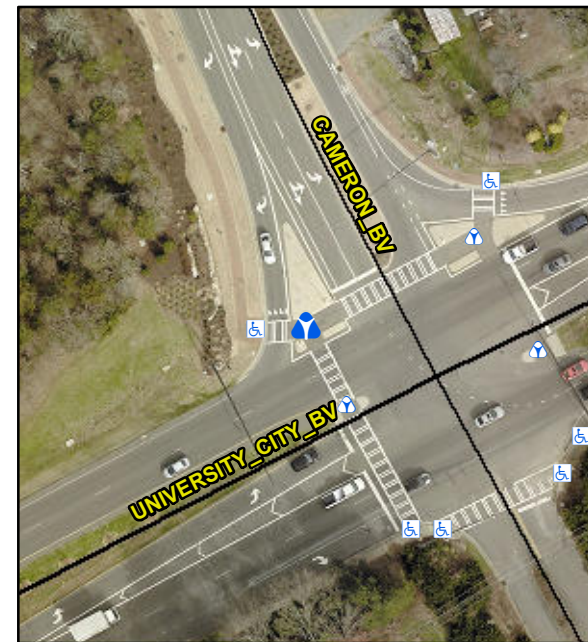
Compliance	Description	Data	Compliance	Description	Data
Yes	Refuge 1 Length (In)	114.0	N/A	Gutter 1 Ponding?	No
Yes	Refuge 1 Width (In)	120.0	N/A	Gutter 1 Lip Ht (In)	N/A
Yes	Refuge 1 Slope (%)	1.3	N/A	Gutter 1 Slope (%)	N/A
Yes	Refuge 1 X Slope (%)	0.6	N/A	Gutter 1 X Slope (%)	N/A
N/A	Painted X Walk1?	Yes	No	DWS 1 Provided?	No
N/A	X Walk 1 Direction	To W	N/A	DWS 1 Contrast?	No
N/A	X Walk 1 Width (In)	119.0	N/A	DWS 1 Length (In)	N/A
N/A	Road 1 Slope (%)	0.6	N/A	DWS 1 Full Width?	No
N/A	Road 1 X Slope (%)	1.3	N/A	DWS 1 Offset (In)	N/A
Yes	Refuge 2 Length (In)	114.0	N/A	Gutter 2 Ponding?	No
Yes	Refuge 2 Width (In)	120.0	N/A	Gutter 2 Lip Ht (In)	N/A
Yes	Refuge 2 Slope (%)	4.2	N/A	Gutter 2 Slope (%)	N/A
Yes	Refuge 2 X Slope (%)	0.1	N/A	Gutter 2 X Slope (%)	N/A
N/A	Painted X Walk2?	Yes	No	DWS 2 Provided?	No
N/A	X Walk 2 Direction	To E	N/A	DWS 2 Contrast?	No
N/A	X Walk 2 Width (In)	115.0	N/A	DWS 2 Length (In)	N/A

N/A	Road 2 Slope (%)	0.1	N/A	DWS 2 Full Width?	No
N/A	Road 2 X Slope (%)	4.3	N/A	DWS 2 Offset (In)	N/A
N/A	Refuge 3 Length (in)	N/A	N/A	Gutter 3 Ponding?	No
N/A	Refuge 3 Width (in)	N/A	N/A	Gutter 3 Lip Ht (in)	N/A
N/A	Refuge 3 Slope (%)	N/A	N/A	Gutter 3 Slope (%)	N/A
N/A	Refuge 3 XSlope (%)	N/A	N/A	Gutter 3 XSlope (%)	N/A
N/A	Painted X Walk3?	No	N/A	DWS 3 Provided?	N/A
N/A	X Walk 3 Direction	N/A	N/A	DWS 3 Contrast?	N/A
N/A	X Walk 3 Width (in)	N/A	N/A	DWS 3 Length (in)	N/A
N/A	Road 3 Slope (%)	N/A	N/A	DWS 3 Full Width?	N/A
N/A	Road 3 XSlope (%)	N/A	N/A	DWS 3 Offset (in)	N/A
Yes	Any Obstructions?	No	N/A	Storm Grate/Utility Hazard?	No
N/A	Obstruction Type		N/A	Storm Grate/Utility Type	
		N/A			N/A
N/A	Surface Condition	Good

Possible Solutions:

Install Detectable Warning System.
