Access Compliance Report

Public Rights-of-Way

(Island Curb Cuts)

Intersection ID: 51371	Main Street: UNIVERSITY_POINTE_BV	Cross Street: N_TRYON_ST	Location: NE
ADA ID: 22708D02D3D5	Curb Cut Type: MedianRefuge2	Initial Pass/Fail: Fail	Overall Compliance: No
Codes/Mitigation Info/Possible Solution		Field Measurements/Component Compliance	
Severity Score: 1.25

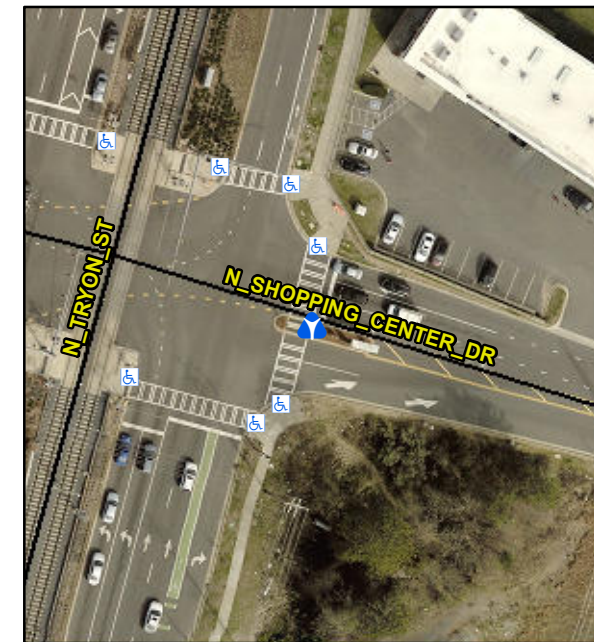
Compliance	Description	Data	Compliance	Description	Data
Yes	Refuge 1 Length (In)	41.0	N/A	Gutter 1 Ponding?	N/A
Yes	Refuge 1 Width (In)	144.0	N/A	Gutter 1 Lip Ht (In)	N/A
Yes	Refuge 1 Slope (%)	4.5	N/A	Gutter 1 Slope (%)	N/A
Yes	Refuge 1 X Slope (%)	2.1	N/A	Gutter 1 X Slope (%)	N/A
N/A	Painted X Walk1?	No	N/A	DWS 1 Provided?	N/A
N/A	X Walk 1 Direction	To NE	N/A	DWS 1 Contrast?	N/A
N/A	X Walk 1 Width (In)	N/A	N/A	DWS 1 Length (In)	N/A
N/A	Road 1 Slope (%)	3.4	N/A	DWS 1 Full Width?	N/A
N/A	Road 1 X Slope (%)	1.3	N/A	DWS 1 Offset (In)	N/A
Yes	Refuge 2 Length (In)	41.0	N/A	Gutter 2 Ponding?	N/A
Yes	Refuge 2 Width (In)	144.0	N/A	Gutter 2 Lip Ht (In)	N/A
Yes	Refuge 2 Slope (%)	1.2	N/A	Gutter 2 Slope (%)	N/A
Yes	Refuge 2 X Slope (%)	2.1	N/A	Gutter 2 X Slope (%)	N/A
N/A	Painted X Walk2?	No	N/A	DWS 2 Provided?	N/A
N/A	X Walk 2 Direction	To S	N/A	DWS 2 Contrast?	N/A
N/A	X Walk 2 Width (In)	N/A	N/A	DWS 2 Length (In)	N/A

N/A	Road 2 Slope (%)	3.6	N/A	DWS 2 Full Width?	N/A
N/A	Road 2 X Slope (%)	0.8	N/A	DWS 2 Offset (In)	N/A
N/A	Refuge 3 Length (in)	N/A	N/A	Gutter 3 Ponding?	N/A
N/A	Refuge 3 Width (in)	N/A	N/A	Gutter 3 Lip Ht (in)	N/A
N/A	Refuge 3 Slope (%)	N/A	N/A	Gutter 3 Slope (%)	N/A
N/A	Refuge 3 XSlope (%)	N/A	N/A	Gutter 3 XSlope (%)	N/A
N/A	Painted X Walk3?	N/A	N/A	DWS 3 Provided?	N/A
N/A	X Walk 3 Direction	N/A	N/A	DWS 3 Contrast?	N/A
N/A	X Walk 3 Width (in)	N/A	N/A	DWS 3 Length (in)	N/A
N/A	Road 3 Slope (%)	N/A	N/A	DWS 3 Full Width?	N/A
N/A	Road 3 XSlope (%)	N/A	N/A	DWS 3 Offset (in)	N/A
Yes	Any Obstructions?	N/A	N/A	Storm Grate/Utility Hazard?	N/A
N/A	Obstruction Type		N/A	Storm Grate/Utility Type	
		N/A			N/A
N/A	Surface Condition	Good

Possible Solutions:

Remove & Replace Entire Refuge.
