# Access Compliance Report

## Public Rights-of-Way

### (Island Curb Cuts)

Intersection ID: 18605	Main Street: MOCKINGBIRD_LN	Cross Street: PARK_RD	Location: E
ADA ID: 228FD5927DCE	Curb Cut Type: MedianRefuge2	Initial Pass/Fail: Fail	Overall Compliance: No
Codes/Mitigation Info/Possible Solution		Field Measurements/Component Compliance

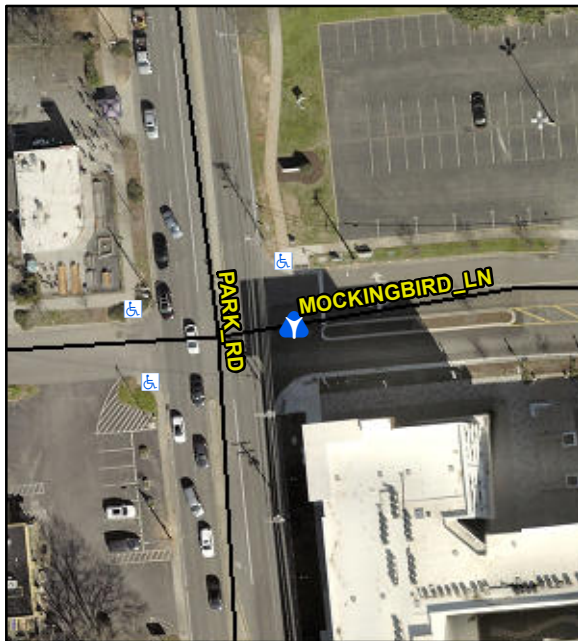
Compliance	Description	Data	Compliance	Description	Data
Yes	Refuge 1 Length (In)	100.5	N/A	Gutter 1 Ponding?	N/A
Yes	Refuge 1 Width (In)	95.0	N/A	Gutter 1 Lip Ht (In)	N/A
Yes	Refuge 1 Slope (%)	1.1	N/A	Gutter 1 Slope (%)	N/A
No	Refuge 1 X Slope (%)	5.9	N/A	Gutter 1 X Slope (%)	N/A
N/A	Painted X Walk1?	No	N/A	DWS 1 Provided?	N/A
N/A	X Walk 1 Direction	To N	N/A	DWS 1 Contrast?	N/A
N/A	X Walk 1 Width (In)	N/A	N/A	DWS 1 Length (In)	N/A
N/A	Road 1 Slope (%)	3.8	N/A	DWS 1 Full Width?	N/A
N/A	Road 1 X Slope (%)	0.3	N/A	DWS 1 Offset (In)	N/A
Yes	Refuge 2 Length (In)	100.5	N/A	Gutter 2 Ponding?	N/A
Yes	Refuge 2 Width (In)	95.0	N/A	Gutter 2 Lip Ht (In)	N/A
Yes	Refuge 2 Slope (%)	3.1	N/A	Gutter 2 Slope (%)	N/A
No	Refuge 2 X Slope (%)	7.9	N/A	Gutter 2 X Slope (%)	N/A
N/A	Painted X Walk2?	No	N/A	DWS 2 Provided?	N/A
N/A	X Walk 2 Direction	To S	N/A	DWS 2 Contrast?	N/A
N/A	X Walk 2 Width (In)	N/A	N/A	DWS 2 Length (In)	N/A

**Remove & Replace Entire Refuge.**

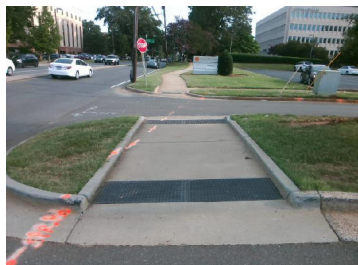
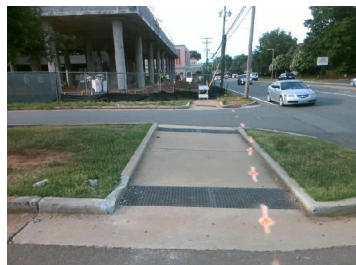
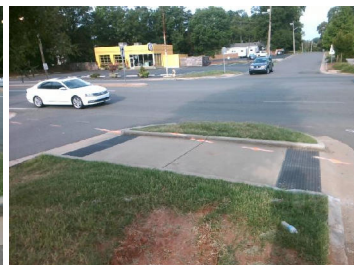
N/A	Road 2 Slope (%)	4.5	N/A	DWS 2 Full Width?	N/A
N/A	Road 2 X Slope (%)	0.9	N/A	DWS 2 Offset (In)	N/A
N/A	Refuge 3 Length (in)	N/A	N/A	Gutter 3 Ponding?	N/A
N/A	Refuge 3 Width (in)	N/A	N/A	Gutter 3 Lip Ht (in)	N/A
N/A	Refuge 3 Slope (%)	N/A	N/A	Gutter 3 Slope (%)	N/A
N/A	Refuge 3 XSlope (%)	N/A	N/A	Gutter 3 XSlope (%)	N/A
N/A	Painted X Walk3?	N/A	N/A	DWS 3 Provided?	N/A
N/A	X Walk 3 Direction	N/A	N/A	DWS 3 Contrast?	N/A
N/A	X Walk 3 Width (in)	N/A	N/A	DWS 3 Length (in)	N/A
N/A	Road 3 Slope (%)	N/A	N/A	DWS 3 Full Width?	N/A
N/A	Road 3 XSlope (%)	N/A	N/A	DWS 3 Offset (in)	N/A
Yes	Any Obstructions?	N/A	N/A	Storm Grate/Utility Hazard?	N/A
N/A	Obstruction Type		N/A	Storm Grate/Utility Type	
		N/A			N/A
N/A	Surface Condition	Good
