Access Compliance Report

Public Rights-of-Way

(Island Curb Cuts)

Intersection ID: 52582	Main Street: NOBLES_AV	Cross Street: BURNETTE_AV	Location: SW
ADA ID: 231878E4EE0A	Curb Cut Type: MedianRefuge2	Initial Pass/Fail: Fail	Overall Compliance: No
Codes/Mitigation Info/Possible Solution		Field Measurements/Component Compliance	
Severity Score: 12.5

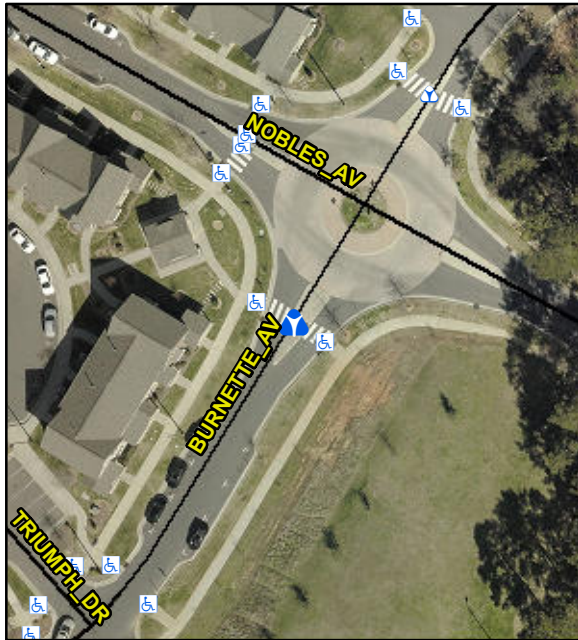
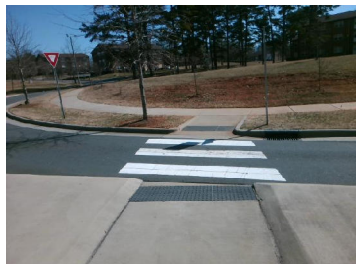
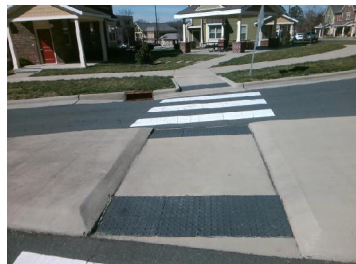
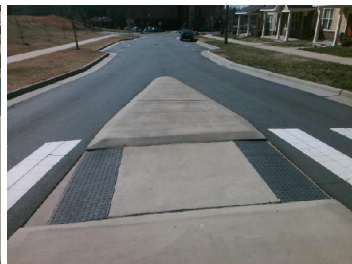
Compliance	Description	Data	Compliance	Description	Data
Yes	Refuge 1 Length (In)	61.5	N/A	Gutter 1 Ponding?	N/A
Yes	Refuge 1 Width (In)	71.0	N/A	Gutter 1 Lip Ht (In)	N/A
No	Refuge 1 Slope (%)	5.8	N/A	Gutter 1 Slope (%)	N/A
Yes	Refuge 1 X Slope (%)	4.2	N/A	Gutter 1 X Slope (%)	N/A
N/A	Painted X Walk1?	Yes	N/A	DWS 1 Provided?	N/A
N/A	X Walk 1 Direction	To SE	N/A	DWS 1 Contrast?	N/A
N/A	X Walk 1 Width (In)	120.0	N/A	DWS 1 Length (In)	N/A
N/A	Road 1 Slope (%)	2.8	N/A	DWS 1 Full Width?	N/A
N/A	Road 1 X Slope (%)	1.6	N/A	DWS 1 Offset (In)	N/A
Yes	Refuge 2 Length (In)	61.5	N/A	Gutter 2 Ponding?	N/A
Yes	Refuge 2 Width (In)	71.0	N/A	Gutter 2 Lip Ht (In)	N/A
No	Refuge 2 Slope (%)	6.6	N/A	Gutter 2 Slope (%)	N/A
Yes	Refuge 2 X Slope (%)	3.0	N/A	Gutter 2 X Slope (%)	N/A
N/A	Painted X Walk2?	Yes	N/A	DWS 2 Provided?	N/A
N/A	X Walk 2 Direction	To NW	N/A	DWS 2 Contrast?	N/A
N/A	X Walk 2 Width (In)	116.5	N/A	DWS 2 Length (In)	N/A

N/A	Road 2 Slope (%)	3.7	N/A	DWS 2 Full Width?	N/A
N/A	Road 2 X Slope (%)	2.4	N/A	DWS 2 Offset (In)	N/A
N/A	Refuge 3 Length (in)	N/A	N/A	Gutter 3 Ponding?	N/A
N/A	Refuge 3 Width (in)	N/A	N/A	Gutter 3 Lip Ht (in)	N/A
N/A	Refuge 3 Slope (%)	N/A	N/A	Gutter 3 Slope (%)	N/A
N/A	Refuge 3 XSlope (%)	N/A	N/A	Gutter 3 XSlope (%)	N/A
N/A	Painted X Walk3?	N/A	N/A	DWS 3 Provided?	N/A
N/A	X Walk 3 Direction	N/A	N/A	DWS 3 Contrast?	N/A
N/A	X Walk 3 Width (in)	N/A	N/A	DWS 3 Length (in)	N/A
N/A	Road 3 Slope (%)	N/A	N/A	DWS 3 Full Width?	N/A
N/A	Road 3 XSlope (%)	N/A	N/A	DWS 3 Offset (in)	N/A
Yes	Any Obstructions?	N/A	N/A	Storm Grate/Utility Hazard?	N/A
N/A	Obstruction Type		N/A	Storm Grate/Utility Type	
		N/A			N/A
N/A	Surface Condition	Good

Remove & Replace Entire Refuge.

\$ 3000.00
