# Access Compliance Report

## Public Rights-of-Way

### (Island Curb Cuts)

Intersection ID: 53270	Main Street: MERIDIAN_CENTER_DR	Cross Street: MONROE_RD	Location: SE
ADA ID: 2473C92FBB8E	Curb Cut Type: MedianRefuge2	Initial Pass/Fail: Fail	Overall Compliance: No
Severity Score: 0			
Codes/Mitigation Info/Possible Solution		Field Measurements/Component Compliance

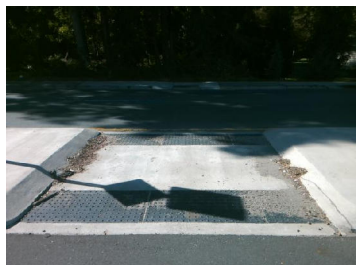
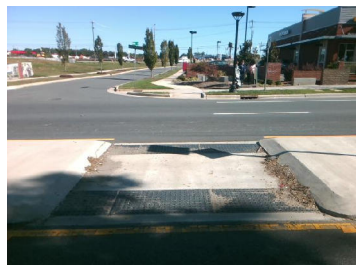
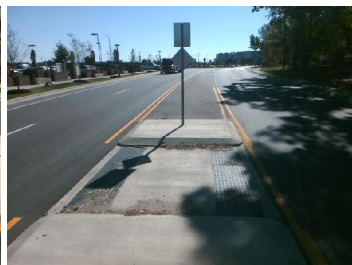
Compliance	Description	Data	Compliance	Description	Data
Yes	Refuge 1 Length (In)	53.5	N/A	Gutter 1 Ponding?	N/A
Yes	Refuge 1 Width (In)	122.0	N/A	Gutter 1 Lip Ht (In)	N/A
Yes	Refuge 1 Slope (%)	1.0	N/A	Gutter 1 Slope (%)	N/A
Yes	Refuge 1 X Slope (%)	2.8	N/A	Gutter 1 X Slope (%)	N/A
N/A	Painted X Walk1?	No	N/A	DWS 1 Provided?	N/A
N/A	X Walk 1 Direction	To SW	N/A	DWS 1 Contrast?	N/A
N/A	X Walk 1 Width (In)	N/A	N/A	DWS 1 Length (In)	N/A
N/A	Road 1 Slope (%)	2.2	N/A	DWS 1 Full Width?	N/A
N/A	Road 1 X Slope (%)	4.9	N/A	DWS 1 Offset (In)	N/A
Yes	Refuge 2 Length (In)	53.5	N/A	Gutter 2 Ponding?	N/A
Yes	Refuge 2 Width (In)	122.0	N/A	Gutter 2 Lip Ht (In)	N/A
Yes	Refuge 2 Slope (%)	0.9	N/A	Gutter 2 Slope (%)	N/A
Yes	Refuge 2 X Slope (%)	1.8	N/A	Gutter 2 X Slope (%)	N/A
N/A	Painted X Walk2?	No	N/A	DWS 2 Provided?	N/A
N/A	X Walk 2 Direction	To NE	N/A	DWS 2 Contrast?	N/A
N/A	X Walk 2 Width (In)	N/A	N/A	DWS 2 Length (In)	N/A

N/A	Road 2 Slope (%)	1.9	N/A	DWS 2 Full Width?	N/A
N/A	Road 2 X Slope (%)	2.3	N/A	DWS 2 Offset (In)	N/A
N/A	Refuge 3 Length (in)	N/A	N/A	Gutter 3 Ponding?	N/A
N/A	Refuge 3 Width (in)	N/A	N/A	Gutter 3 Lip Ht (in)	N/A
N/A	Refuge 3 Slope (%)	N/A	N/A	Gutter 3 Slope (%)	N/A
N/A	Refuge 3 XSlope (%)	N/A	N/A	Gutter 3 XSlope (%)	N/A
N/A	Painted X Walk3?	N/A	N/A	DWS 3 Provided?	N/A
N/A	X Walk 3 Direction	N/A	N/A	DWS 3 Contrast?	N/A
N/A	X Walk 3 Width (in)	N/A	N/A	DWS 3 Length (in)	N/A
N/A	Road 3 Slope (%)	N/A	N/A	DWS 3 Full Width?	N/A
N/A	Road 3 XSlope (%)	N/A	N/A	DWS 3 Offset (in)	N/A
Yes	Any Obstructions?	N/A	N/A	Storm Grate/Utility Hazard?	N/A
N/A	Obstruction Type		N/A	Storm Grate/Utility Type	
		N/A			N/A
N/A	Surface Condition	Good

**Remove & Replace Entire Refuge.**
