Access Compliance Report

Public Rights-of-Way

(Island Curb Cuts)

Intersection ID: 5600	Main Street: N_TRYON_ST	Cross Street: J_M_KEYNES_DR	Location: E
ADA ID: 2543BCF0BAB9	Curb Cut Type: MedianRefuge2	Initial Pass/Fail: Fail	Overall Compliance: No
Codes/Mitigation Info/Possible Solution		Field Measurements/Component Compliance	
Severity Score: 0

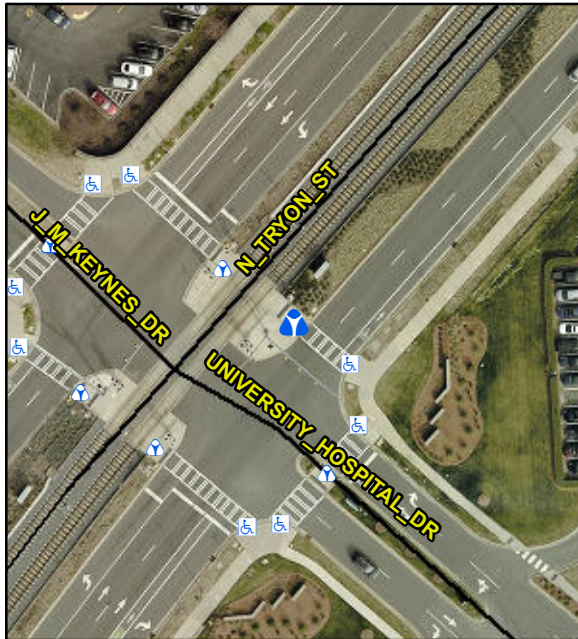
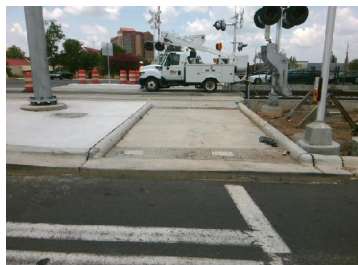
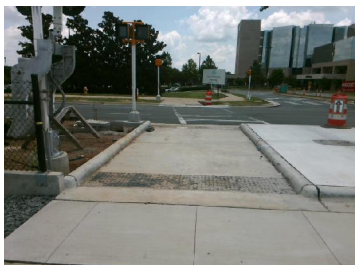
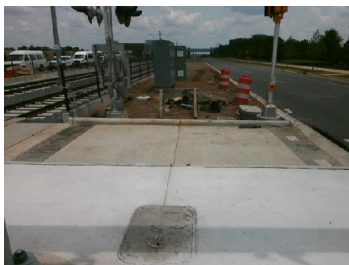
Compliance	Description	Data	Compliance	Description	Data
Yes	Refuge 1 Length (In)	114.0	N/A	Gutter 1 Ponding?	N/A
Yes	Refuge 1 Width (In)	120.0	N/A	Gutter 1 Lip Ht (In)	N/A
Yes	Refuge 1 Slope (%)	1.7	N/A	Gutter 1 Slope (%)	N/A
Yes	Refuge 1 X Slope (%)	0.7	N/A	Gutter 1 X Slope (%)	N/A
N/A	Painted X Walk1?	Yes	N/A	DWS 1 Provided?	N/A
N/A	X Walk 1 Direction	To SE	N/A	DWS 1 Contrast?	N/A
N/A	X Walk 1 Width (In)	120.0	N/A	DWS 1 Length (In)	N/A
N/A	Road 1 Slope (%)	0.7	N/A	DWS 1 Full Width?	N/A
N/A	Road 1 X Slope (%)	2.5	N/A	DWS 1 Offset (In)	N/A
Yes	Refuge 2 Length (In)	113.0	N/A	Gutter 2 Ponding?	N/A
Yes	Refuge 2 Width (In)	120.0	N/A	Gutter 2 Lip Ht (In)	N/A
Yes	Refuge 2 Slope (%)	0.0	N/A	Gutter 2 Slope (%)	N/A
Yes	Refuge 2 X Slope (%)	0.1	N/A	Gutter 2 X Slope (%)	N/A
N/A	Painted X Walk2?	No	N/A	DWS 2 Provided?	N/A
N/A	X Walk 2 Direction	To NW	N/A	DWS 2 Contrast?	N/A
N/A	X Walk 2 Width (In)	N/A	N/A	DWS 2 Length (In)	N/A

N/A	Road 2 Slope (%)	0.6	N/A	DWS 2 Full Width?	N/A
N/A	Road 2 X Slope (%)	0.6	N/A	DWS 2 Offset (In)	N/A
N/A	Refuge 3 Length (in)	N/A	N/A	Gutter 3 Ponding?	N/A
N/A	Refuge 3 Width (in)	N/A	N/A	Gutter 3 Lip Ht (in)	N/A
N/A	Refuge 3 Slope (%)	N/A	N/A	Gutter 3 Slope (%)	N/A
N/A	Refuge 3 XSlope (%)	N/A	N/A	Gutter 3 XSlope (%)	N/A
N/A	Painted X Walk3?	No	N/A	DWS 3 Provided?	N/A
N/A	X Walk 3 Direction	N/A	N/A	DWS 3 Contrast?	N/A
N/A	X Walk 3 Width (in)	N/A	N/A	DWS 3 Length (in)	N/A
N/A	Road 3 Slope (%)	N/A	N/A	DWS 3 Full Width?	N/A
N/A	Road 3 XSlope (%)	N/A	N/A	DWS 3 Offset (in)	N/A
Yes	Any Obstructions?	N/A	N/A	Storm Grate/Utility Hazard?	N/A
N/A	Obstruction Type		N/A	Storm Grate/Utility Type	
		N/A			N/A
N/A	Surface Condition	Good

Remove & Replace Entire Refuge.

Total Cost: \$ 3000.00
