Access Compliance Report

Public Rights-of-Way

(Island Curb Cuts)

Intersection ID: 19805	Main Street: MORRISON_BV	Cross Street: SOUTH_PARK_DR	Location: SE
ADA ID: 27B0BD0211E6	Curb Cut Type: IslandRefuge3	Initial Pass/Fail: Fail	Overall Compliance: No
Codes/Mitigation Info/Possible Solution		Field Measurements/Component Compliance	
Severity Score: 47.5

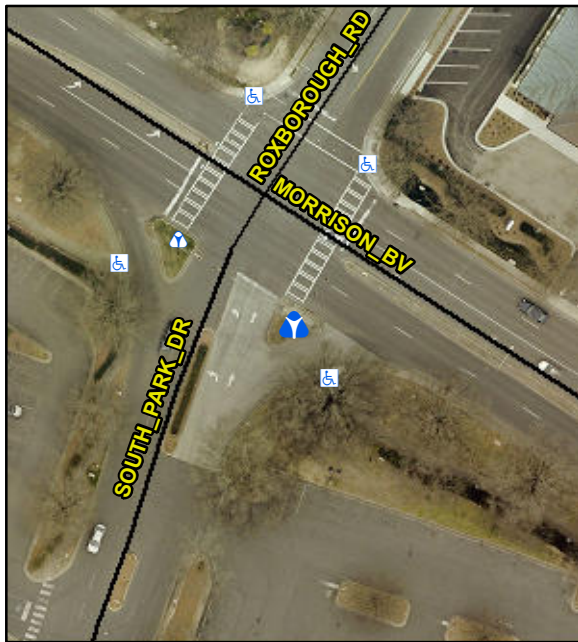
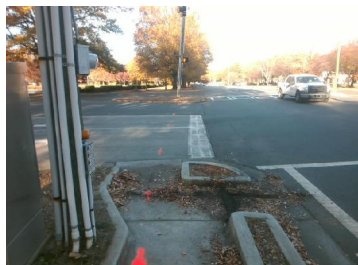
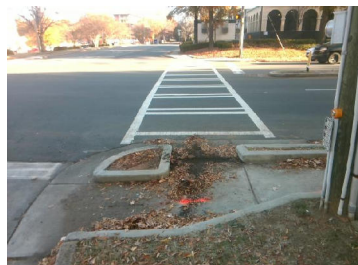
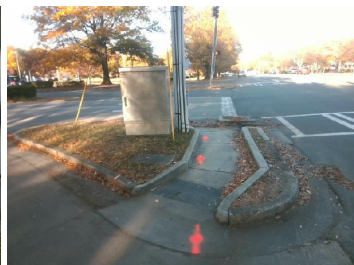
Compliance	Description	Data	Compliance	Description	Data
No	Refuge 1 Length (In)	44.0	N/A	Gutter 1 Ponding?	N/A
No	Refuge 1 Width (In)	47.0	N/A	Gutter 1 Lip Ht (In)	N/A
Yes	Refuge 1 Slope (%)	1.2	N/A	Gutter 1 Slope (%)	N/A
Yes	Refuge 1 X Slope (%)	0.7	N/A	Gutter 1 X Slope (%)	N/A
N/A	Painted X Walk1?	No	N/A	DWS 1 Provided?	N/A
N/A	X Walk 1 Direction	To NW	N/A	DWS 1 Contrast?	N/A
N/A	X Walk 1 Width (In)	N/A	N/A	DWS 1 Length (In)	N/A
N/A	Road 1 Slope (%)	1.8	N/A	DWS 1 Full Width?	N/A
N/A	Road 1 X Slope (%)	2.1	N/A	DWS 1 Offset (In)	N/A
No	Refuge 2 Length (In)	22.0	N/A	Gutter 2 Ponding?	N/A
No	Refuge 2 Width (In)	45.5	N/A	Gutter 2 Lip Ht (In)	N/A
Yes	Refuge 2 Slope (%)	2.1	N/A	Gutter 2 Slope (%)	N/A
Yes	Refuge 2 X Slope (%)	0.8	N/A	Gutter 2 X Slope (%)	N/A
N/A	Painted X Walk2?	Yes	N/A	DWS 2 Provided?	N/A
N/A	X Walk 2 Direction	To NE	N/A	DWS 2 Contrast?	N/A
N/A	X Walk 2 Width (In)	110.0	N/A	DWS 2 Length (In)	N/A

N/A	Road 2 Slope (%)	0.7	N/A	DWS 2 Full Width?	N/A
N/A	Road 2 X Slope (%)	4.5	N/A	DWS 2 Offset (In)	N/A
No	Refuge 3 Length (in)	182.0	N/A	Gutter 3 Ponding?	N/A
No	Refuge 3 Width (in)	48.0	N/A	Gutter 3 Lip Ht (in)	N/A
No	Refuge 3 Slope (%)	5.7	N/A	Gutter 3 Slope (%)	N/A
Yes	Refuge 3 XSlope (%)	0.2	N/A	Gutter 3 XSlope (%)	N/A
N/A	Painted X Walk3?	No	N/A	DWS 3 Provided?	N/A
N/A	X Walk 3 Direction	To SE	N/A	DWS 3 Contrast?	N/A
N/A	X Walk 3 Width (in)	N/A	N/A	DWS 3 Length (in)	N/A
N/A	Road 3 Slope (%)	0.6	N/A	DWS 3 Full Width?	N/A
N/A	Road 3 XSlope (%)	0.6	N/A	DWS 3 Offset (in)	N/A
Yes	Any Obstructions?	N/A	N/A	Storm Grate/Utility Hazard?	N/A
N/A	Obstruction Type		N/A	Storm Grate/Utility Type	
			N/A		N/A
N/A	Surface Condition	Good

Possible Solutions:

Remove & Replace Entire Refuge.
