Access Compliance Report

Public Rights-of-Way

(Island Curb Cuts)

Intersection ID: 10040110	Main Street: TUCKASEEGEE_RD	Cross Street: N/A	Location: S
ADA ID: 2891EA0A3EF6	Curb Cut Type: MedianRefuge2	Initial Pass/Fail: Fail	Overall Compliance: No
			Severity Score: 1.25

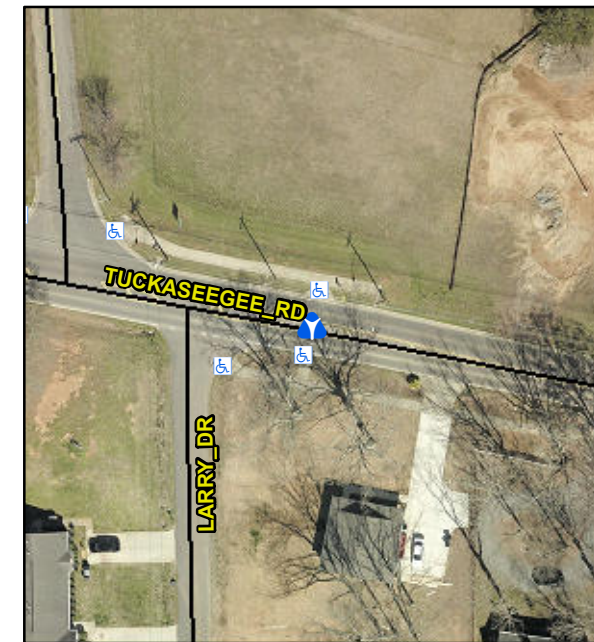
Compliance	Description	Data	Compliance	Description	Data
No	Refuge 1 Length (In)	30.0	N/A	Gutter 1 Ponding?	N/A
Yes	Refuge 1 Width (In)	96.0	N/A	Gutter 1 Lip Ht (In)	N/A
Yes	Refuge 1 Slope (%)	1.5	N/A	Gutter 1 Slope (%)	N/A
Yes	Refuge 1 X Slope (%)	0.0	N/A	Gutter 1 X Slope (%)	N/A
N/A	Painted X Walk1?	No	N/A	DWS 1 Provided?	N/A
N/A	X Walk 1 Direction	To S	N/A	DWS 1 Contrast?	N/A
N/A	X Walk 1 Width (In)	N/A	N/A	DWS 1 Length (In)	N/A
N/A	Road 1 Slope (%)	1.0	N/A	DWS 1 Full Width?	N/A
N/A	Road 1 X Slope (%)	0.4	N/A	DWS 1 Offset (In)	N/A
No	Refuge 2 Length (In)	30.0	N/A	Gutter 2 Ponding?	N/A
Yes	Refuge 2 Width (In)	96.0	N/A	Gutter 2 Lip Ht (In)	N/A
Yes	Refuge 2 Slope (%)	4.8	N/A	Gutter 2 Slope (%)	N/A
Yes	Refuge 2 X Slope (%)	2.1	N/A	Gutter 2 X Slope (%)	N/A
N/A	Painted X Walk2?	No	N/A	DWS 2 Provided?	N/A
N/A	X Walk 2 Direction	To N	N/A	DWS 2 Contrast?	N/A
N/A	X Walk 2 Width (In)	N/A	N/A	DWS 2 Length (In)	N/A

N/A	Road 2 Slope (%)	1.0	N/A	DWS 2 Full Width?	N/A
N/A	Road 2 X Slope (%)	3.9	N/A	DWS 2 Offset (In)	N/A
N/A	Refuge 3 Length (in)	N/A	N/A	Gutter 3 Ponding?	N/A
N/A	Refuge 3 Width (in)	N/A	N/A	Gutter 3 Lip Ht (in)	N/A
N/A	Refuge 3 Slope (%)	N/A	N/A	Gutter 3 Slope (%)	N/A
N/A	Refuge 3 XSlope (%)	N/A	N/A	Gutter 3 XSlope (%)	N/A
N/A	Painted X Walk3?	N/A	N/A	DWS 3 Provided?	N/A
N/A	X Walk 3 Direction	N/A	N/A	DWS 3 Contrast?	N/A
N/A	X Walk 3 Width (in)	N/A	N/A	DWS 3 Length (in)	N/A
N/A	Road 3 Slope (%)	N/A	N/A	DWS 3 Full Width?	N/A
N/A	Road 3 XSlope (%)	N/A	N/A	DWS 3 Offset (in)	N/A
Yes	Any Obstructions?	N/A	N/A	Storm Grate/Utility Hazard?	N/A
N/A	Obstruction Type		N/A	Storm Grate/Utility Type	
		N/A			N/A
N/A	Surface Condition	Good

Remove & Replace Entire Refuge.

\$ 3000.00
