Access Compliance Report

Public Rights-of-Way

(Island Curb Cuts)

Intersection ID: 10020275	Main Street: AYRSLEY_TOWN_BV	Cross Street: N/A	Location: E
ADA ID: 28DB6340B3B0	Curb Cut Type: MedianRefuge2	Initial Pass/Fail: Fail	Overall Compliance: No
Codes/Mitigation Info/Possible Solution		Field Measurements/Component Compliance

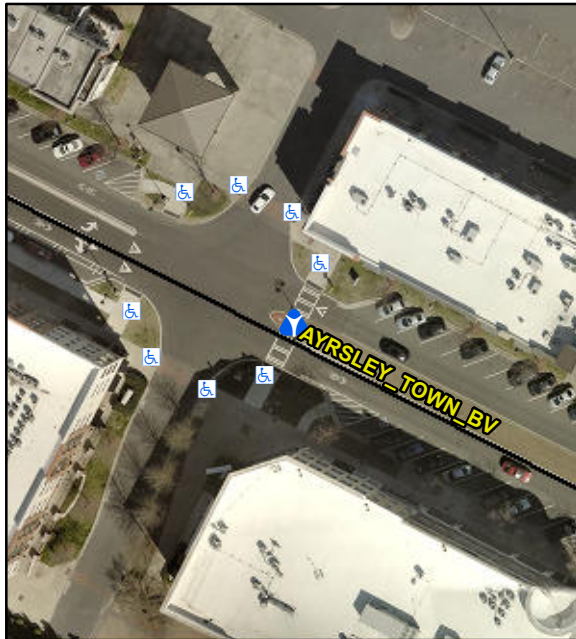
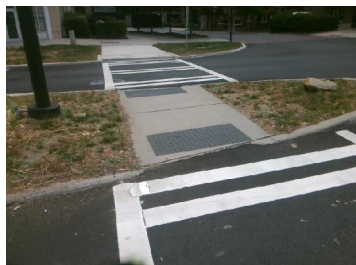
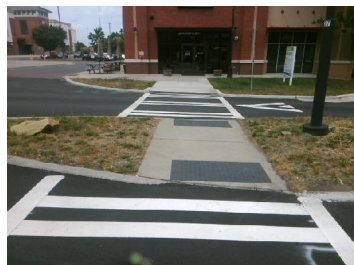
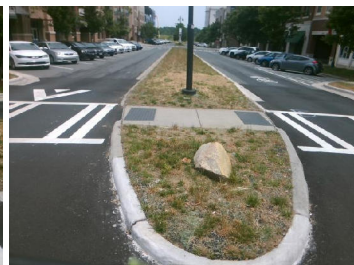
Compliance	Description	Data	Compliance	Description	Data
Yes	Refuge 1 Length (In)	66.0	N/A	Gutter 1 Ponding?	N/A
Yes	Refuge 1 Width (In)	71.0	N/A	Gutter 1 Lip Ht (In)	N/A
Yes	Refuge 1 Slope (%)	2.2	N/A	Gutter 1 Slope (%)	N/A
Yes	Refuge 1 X Slope (%)	4.1	N/A	Gutter 1 X Slope (%)	N/A
N/A	Painted X Walk1?	Yes	N/A	DWS 1 Provided?	N/A
N/A	X Walk 1 Direction	To NE	N/A	DWS 1 Contrast?	N/A
N/A	X Walk 1 Width (In)	103.5	N/A	DWS 1 Length (In)	N/A
N/A	Road 1 Slope (%)	2.8	N/A	DWS 1 Full Width?	N/A
N/A	Road 1 X Slope (%)	2.8	N/A	DWS 1 Offset (In)	N/A
Yes	Refuge 2 Length (In)	66.0	N/A	Gutter 2 Ponding?	N/A
Yes	Refuge 2 Width (In)	71.0	N/A	Gutter 2 Lip Ht (In)	N/A
Yes	Refuge 2 Slope (%)	2.1	N/A	Gutter 2 Slope (%)	N/A
Yes	Refuge 2 X Slope (%)	1.7	N/A	Gutter 2 X Slope (%)	N/A
N/A	Painted X Walk2?	Yes	N/A	DWS 2 Provided?	N/A
N/A	X Walk 2 Direction	To SW	N/A	DWS 2 Contrast?	N/A
N/A	X Walk 2 Width (In)	104.0	N/A	DWS 2 Length (In)	N/A

N/A	Road 2 Slope (%)	2.7	N/A	DWS 2 Full Width?	N/A
N/A	Road 2 X Slope (%)	2.1	N/A	DWS 2 Offset (In)	N/A
N/A	Refuge 3 Length (in)	N/A	N/A	Gutter 3 Ponding?	N/A
N/A	Refuge 3 Width (in)	N/A	N/A	Gutter 3 Lip Ht (in)	N/A
N/A	Refuge 3 Slope (%)	N/A	N/A	Gutter 3 Slope (%)	N/A
N/A	Refuge 3 XSlope (%)	N/A	N/A	Gutter 3 XSlope (%)	N/A
N/A	Painted X Walk3?	N/A	N/A	DWS 3 Provided?	N/A
N/A	X Walk 3 Direction	N/A	N/A	DWS 3 Contrast?	N/A
N/A	X Walk 3 Width (in)	N/A	N/A	DWS 3 Length (in)	N/A
N/A	Road 3 Slope (%)	N/A	N/A	DWS 3 Full Width?	N/A
N/A	Road 3 XSlope (%)	N/A	N/A	DWS 3 Offset (in)	N/A
Yes	Any Obstructions?	N/A	N/A	Storm Grate/Utility Hazard?	N/A
N/A	Obstruction Type		N/A	Storm Grate/Utility Type	
		N/A			N/A
N/A	Surface Condition	Good

Remove & Replace Entire Refuge.
