Access Compliance Report

Public Rights-of-Way

(Island Curb Cuts)

Intersection ID: 11208	Main Street: PARKWOOD_AV	Cross Street: N_BREVARD_ST	Location: E
ADA ID: 28F51DAEE08D	Curb Cut Type: MedianRefuge2	Initial Pass/Fail: Pass	Overall Compliance: No
Severity Score: 10.25			
Codes/Mitigation Info/Possible Solution		Field Measurements/Component Compliance

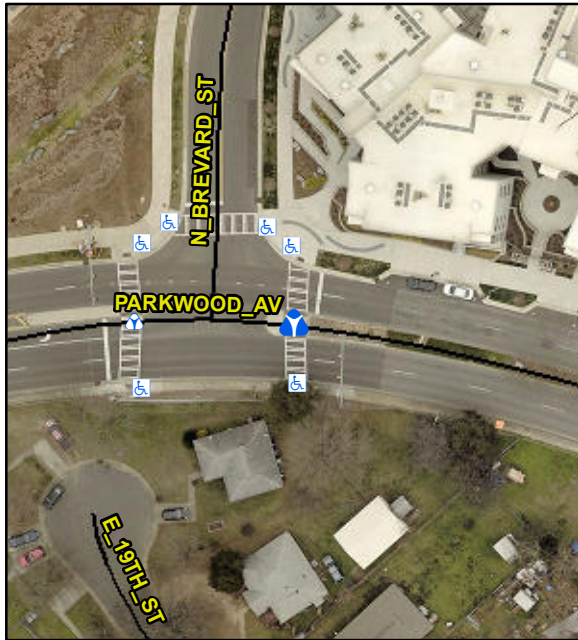
Compliance	Description	Data	Compliance	Description	Data
Yes	Refuge 1 Length (In)	80.0	Yes	Gutter 1 Ponding?	No
Yes	Refuge 1 Width (In)	143.0	Yes	Gutter 1 Lip Ht (In)	0.0
Yes	Refuge 1 Slope (%)	2.0	No	Gutter 1 Slope (%)	5.4
Yes	Refuge 1 X Slope (%)	0.5	Yes	Gutter 1 X Slope (%)	0.1
N/A	Painted X Walk1?	Yes	Yes	DWS 1 Provided?	Yes
N/A	X Walk 1 Direction	To N	Yes	DWS 1 Contrast?	Yes
N/A	X Walk 1 Width (In)	113.0	No	DWS 1 Length (In)	23.0
N/A	Road 1 Slope (%)	0.4	Yes	DWS 1 Full Width?	Yes
N/A	Road 1 X Slope (%)	4.3	Yes	DWS 1 Offset (In)	0.0
Yes	Refuge 2 Length (In)	82.0	Yes	Gutter 2 Ponding?	No
Yes	Refuge 2 Width (In)	143.0	Yes	Gutter 2 Lip Ht (In)	0.0
Yes	Refuge 2 Slope (%)	3.7	Yes	Gutter 2 Slope (%)	3.0
Yes	Refuge 2 X Slope (%)	0.1	Yes	Gutter 2 X Slope (%)	0.7
N/A	Painted X Walk2?	Yes	Yes	DWS 2 Provided?	Yes
N/A	X Walk 2 Direction	To S	Yes	DWS 2 Contrast?	Yes
N/A	X Walk 2 Width (In)	115.0	No	DWS 2 Length (In)	23.5

N/A	Road 2 Slope (%)	0.9	Yes	DWS 2 Full Width?	Yes
N/A	Road 2 X Slope (%)	2.9	Yes	DWS 2 Offset (In)	0.0
N/A	Refuge 3 Length (in)	N/A	N/A	Gutter 3 Ponding?	N/A
N/A	Refuge 3 Width (in)	N/A	N/A	Gutter 3 Lip Ht (in)	N/A
N/A	Refuge 3 Slope (%)	N/A	N/A	Gutter 3 Slope (%)	N/A
N/A	Refuge 3 XSlope (%)	N/A	N/A	Gutter 3 XSlope (%)	N/A
N/A	Painted X Walk3?	N/A	N/A	DWS 3 Provided?	N/A
N/A	X Walk 3 Direction	N/A	N/A	DWS 3 Contrast?	N/A
N/A	X Walk 3 Width (in)	N/A	N/A	DWS 3 Length (in)	N/A
N/A	Road 3 Slope (%)	N/A	N/A	DWS 3 Full Width?	N/A
N/A	Road 3 XSlope (%)	N/A	N/A	DWS 3 Offset (in)	N/A
Yes	Any Obstructions?	No	N/A	Storm Grate/Utility Hazard?	No
N/A	Obstruction Type		N/A	Storm Grate/Utility Type	
		N/A			N/A
N/A	Surface Condition	Good

Remove & Replace Detectable Warning System. Remove & Replace Gutter.
