Access Compliance Report

Public Rights-of-Way

(Island Curb Cuts)

Intersection ID: 51379	Main Street: BROADRICK_BV	Cross Street: UNIVERSITY_CITY_BV	Location: E
ADA ID: 294ADA3F59A8	Curb Cut Type: MedianRefuge2	Initial Pass/Fail: Pass	Overall Compliance: No
Severity Score: 5.25			
Codes/Mitigation Info/Possible Solution		Field Measurements/Component Compliance

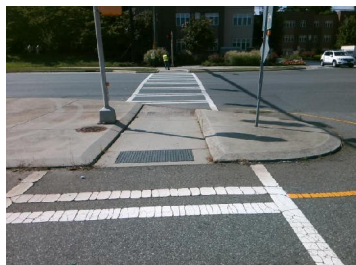
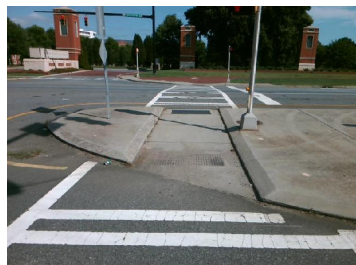
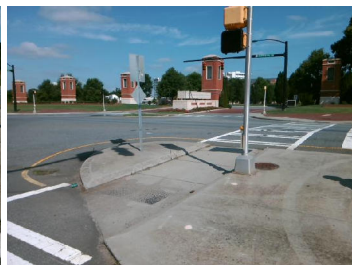
Compliance	Description	Data	Compliance	Description	Data
Yes	Refuge 1 Length (In)	123.0	Yes	Gutter 1 Ponding?	No
Yes	Refuge 1 Width (In)	72.0	Yes	Gutter 1 Lip Ht (In)	0.0
Yes	Refuge 1 Slope (%)	3.8	Yes	Gutter 1 Slope (%)	1.8
Yes	Refuge 1 X Slope (%)	0.6	Yes	Gutter 1 X Slope (%)	0.8
N/A	Painted X Walk1?	Yes	Yes	DWS 1 Provided?	Yes
N/A	X Walk 1 Direction	To NW	Yes	DWS 1 Contrast?	Yes
N/A	X Walk 1 Width (In)	113.0	Yes	DWS 1 Length (In)	24.0
N/A	Road 1 Slope (%)	0.8	No	DWS 1 Full Width?	No
N/A	Road 1 X Slope (%)	1.8	No	DWS 1 Offset (In)	7.0
Yes	Refuge 2 Length (In)	123.0	Yes	Gutter 2 Ponding?	No
Yes	Refuge 2 Width (In)	72.0	Yes	Gutter 2 Lip Ht (In)	0.0
Yes	Refuge 2 Slope (%)	0.2	Yes	Gutter 2 Slope (%)	1.3
Yes	Refuge 2 X Slope (%)	1.8	Yes	Gutter 2 X Slope (%)	0.1
N/A	Painted X Walk2?	Yes	Yes	DWS 2 Provided?	Yes
N/A	X Walk 2 Direction	To SE	Yes	DWS 2 Contrast?	Yes
N/A	X Walk 2 Width (In)	119.0	Yes	DWS 2 Length (In)	24.0

N/A	Road 2 Slope (%)	0.1	No	DWS 2 Full Width?	No
N/A	Road 2 X Slope (%)	1.3	No	DWS 2 Offset (In)	25.0
N/A	Refuge 3 Length (in)	N/A	N/A	Gutter 3 Ponding?	No
N/A	Refuge 3 Width (in)	N/A	N/A	Gutter 3 Lip Ht (in)	0.0
N/A	Refuge 3 Slope (%)	N/A	N/A	Gutter 3 Slope (%)	N/A
N/A	Refuge 3 XSlope (%)	N/A	N/A	Gutter 3 XSlope (%)	N/A
N/A	Painted X Walk3?	No	N/A	DWS 3 Provided?	N/A
N/A	X Walk 3 Direction	N/A	N/A	DWS 3 Contrast?	N/A
N/A	X Walk 3 Width (in)	N/A	N/A	DWS 3 Length (in)	N/A
N/A	Road 3 Slope (%)	N/A	N/A	DWS 3 Full Width?	N/A
N/A	Road 3 XSlope (%)	N/A	N/A	DWS 3 Offset (in)	N/A
Yes	Any Obstructions?	No	N/A	Storm Grate/Utility Hazard?	No
N/A	Obstruction Type		N/A	Storm Grate/Utility Type	
		N/A			N/A
N/A	Surface Condition	Good

Remove & Replace Detectable Warning System.
