Access Compliance Report

Public Rights-of-Way

(Island Curb Cuts)

Intersection ID: 21746	Main Street: INTERNATIONAL_DR	Cross Street: PROVIDENCE_RD	Location: NE
ADA ID: 294F7F8B1AAF	Curb Cut Type: MedianRefuge2	Initial Pass/Fail: Fail	Overall Compliance: No
Codes/Mitigation Info/Possible Solution		Field Measurements/Component Compliance	
Severity Score: 12.5

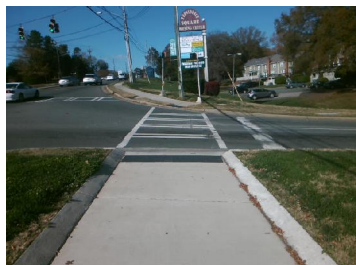
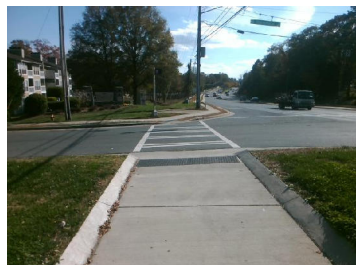
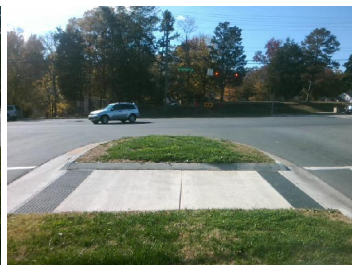
Compliance	Description	Data	Compliance	Description	Data
Yes	Refuge 1 Length (In)	111.5	N/A	Gutter 1 Ponding?	N/A
Yes	Refuge 1 Width (In)	99.0	N/A	Gutter 1 Lip Ht (In)	N/A
Yes	Refuge 1 Slope (%)	1.0	N/A	Gutter 1 Slope (%)	N/A
No	Refuge 1 X Slope (%)	9.3	N/A	Gutter 1 X Slope (%)	N/A
N/A	Painted X Walk1?	Yes	N/A	DWS 1 Provided?	N/A
N/A	X Walk 1 Direction	To NW	N/A	DWS 1 Contrast?	N/A
N/A	X Walk 1 Width (In)	107.0	N/A	DWS 1 Length (In)	N/A
N/A	Road 1 Slope (%)	6.5	N/A	DWS 1 Full Width?	N/A
N/A	Road 1 X Slope (%)	5.9	N/A	DWS 1 Offset (In)	N/A
Yes	Refuge 2 Length (In)	111.5	N/A	Gutter 2 Ponding?	N/A
Yes	Refuge 2 Width (In)	99.0	N/A	Gutter 2 Lip Ht (In)	N/A
Yes	Refuge 2 Slope (%)	1.4	N/A	Gutter 2 Slope (%)	N/A
No	Refuge 2 X Slope (%)	7.0	N/A	Gutter 2 X Slope (%)	N/A
N/A	Painted X Walk2?	Yes	N/A	DWS 2 Provided?	N/A
N/A	X Walk 2 Direction	To SE	N/A	DWS 2 Contrast?	N/A
N/A	X Walk 2 Width (In)	107.0	N/A	DWS 2 Length (In)	N/A

N/A	Road 2 Slope (%)	6.5	N/A	DWS 2 Full Width?	N/A
N/A	Road 2 X Slope (%)	5.0	N/A	DWS 2 Offset (In)	N/A
N/A	Refuge 3 Length (in)	N/A	N/A	Gutter 3 Ponding?	N/A
N/A	Refuge 3 Width (in)	N/A	N/A	Gutter 3 Lip Ht (in)	N/A
N/A	Refuge 3 Slope (%)	N/A	N/A	Gutter 3 Slope (%)	N/A
N/A	Refuge 3 XSlope (%)	N/A	N/A	Gutter 3 XSlope (%)	N/A
N/A	Painted X Walk3?	N/A	N/A	DWS 3 Provided?	N/A
N/A	X Walk 3 Direction	N/A	N/A	DWS 3 Contrast?	N/A
N/A	X Walk 3 Width (in)	N/A	N/A	DWS 3 Length (in)	N/A
N/A	Road 3 Slope (%)	N/A	N/A	DWS 3 Full Width?	N/A
N/A	Road 3 XSlope (%)	N/A	N/A	DWS 3 Offset (in)	N/A
Yes	Any Obstructions?	N/A	N/A	Storm Grate/Utility Hazard?	N/A
N/A	Obstruction Type		N/A	Storm Grate/Utility Type	
		N/A			N/A
N/A	Surface Condition	Good

Remove & Replace Entire Refuge.
