Access Compliance Report

Public Rights-of-Way

(Island Curb Cuts)

Intersection ID: 27628	Main Street: BALLANTYNE_COMMONS_PY	Cross Street: ADAIR_MANOR_CT	Location: NW
ADA ID: 2AB12798FE15	Curb Cut Type: MedianRefuge2	Initial Pass/Fail: Fail	Overall Compliance: No
Codes/Mitigation Info/Possible Solution		Field Measurements/Component Compliance

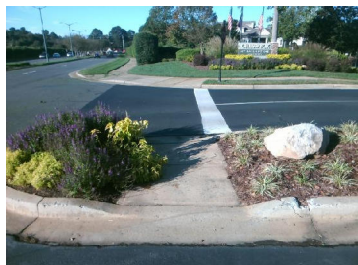
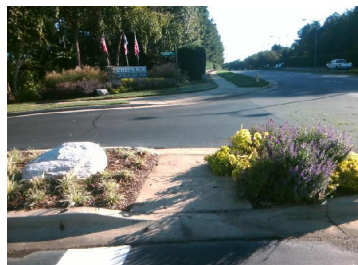
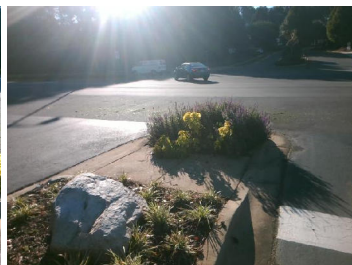
Compliance	Description	Data	Compliance	Description	Data
Yes	Refuge 1 Length (In)	45.0	N/A	Gutter 1 Ponding?	N/A
Yes	Refuge 1 Width (In)	60.0	N/A	Gutter 1 Lip Ht (In)	N/A
Yes	Refuge 1 Slope (%)	1.8	N/A	Gutter 1 Slope (%)	N/A
Yes	Refuge 1 X Slope (%)	3.2	N/A	Gutter 1 X Slope (%)	N/A
N/A	Painted X Walk1?	No	N/A	DWS 1 Provided?	N/A
N/A	X Walk 1 Direction	To NE	N/A	DWS 1 Contrast?	N/A
N/A	X Walk 1 Width (In)	N/A	N/A	DWS 1 Length (In)	N/A
N/A	Road 1 Slope (%)	1.8	N/A	DWS 1 Full Width?	N/A
N/A	Road 1 X Slope (%)	3.1	N/A	DWS 1 Offset (In)	N/A
Yes	Refuge 2 Length (In)	45.0	N/A	Gutter 2 Ponding?	N/A
Yes	Refuge 2 Width (In)	60.0	N/A	Gutter 2 Lip Ht (In)	N/A
Yes	Refuge 2 Slope (%)	3.2	N/A	Gutter 2 Slope (%)	N/A
No	Refuge 2 X Slope (%)	7.8	N/A	Gutter 2 X Slope (%)	N/A
N/A	Painted X Walk2?	No	N/A	DWS 2 Provided?	N/A
N/A	X Walk 2 Direction	To SW	N/A	DWS 2 Contrast?	N/A
N/A	X Walk 2 Width (In)	N/A	N/A	DWS 2 Length (In)	N/A

N/A	Road 2 Slope (%)	1.5	N/A	DWS 2 Full Width?	N/A
N/A	Road 2 X Slope (%)	2.2	N/A	DWS 2 Offset (In)	N/A
N/A	Refuge 3 Length (in)	N/A	N/A	Gutter 3 Ponding?	N/A
N/A	Refuge 3 Width (in)	N/A	N/A	Gutter 3 Lip Ht (in)	N/A
N/A	Refuge 3 Slope (%)	N/A	N/A	Gutter 3 Slope (%)	N/A
N/A	Refuge 3 XSlope (%)	N/A	N/A	Gutter 3 XSlope (%)	N/A
N/A	Painted X Walk3?	N/A	N/A	DWS 3 Provided?	N/A
N/A	X Walk 3 Direction	N/A	N/A	DWS 3 Contrast?	N/A
N/A	X Walk 3 Width (in)	N/A	N/A	DWS 3 Length (in)	N/A
N/A	Road 3 Slope (%)	N/A	N/A	DWS 3 Full Width?	N/A
N/A	Road 3 XSlope (%)	N/A	N/A	DWS 3 Offset (in)	N/A
Yes	Any Obstructions?	N/A	N/A	Storm Grate/Utility Hazard?	N/A
N/A	Obstruction Type		N/A	Storm Grate/Utility Type	
			N/A		N/A
N/A	Surface Condition	Good

Remove & Replace Entire Refuge.
