Access Compliance Report

Public Rights-of-Way

(Island Curb Cuts)

Intersection ID: 13588	Main Street: CENTRAL_AV	Cross Street: WEMBLEY_DR	Location:	N/A
ADA ID: 2ADA594ECEBB	Curb Cut Type: MedianRefuge2	Initial Pass/Fail: Fail	Overall Compliance: No	Severity Score: 13.75
Codes/Mitigation Info/Possible Solution		Field Measurements/Component Compliance

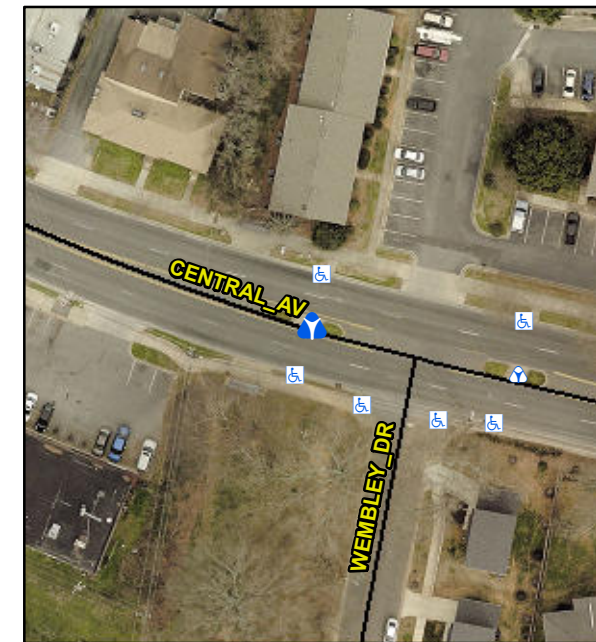
Compliance	Description	Data	Compliance	Description	Data
Yes	Refuge 1 Length (In)	37.0	N/A	Gutter 1 Ponding?	N/A
Yes	Refuge 1 Width (In)	173.0	N/A	Gutter 1 Lip Ht (In)	N/A
Yes	Refuge 1 Slope (%)	5.0	N/A	Gutter 1 Slope (%)	N/A
Yes	Refuge 1 X Slope (%)	4.3	N/A	Gutter 1 X Slope (%)	N/A
N/A	Painted X Walk1?	No	N/A	DWS 1 Provided?	N/A
N/A	X Walk 1 Direction	To N	N/A	DWS 1 Contrast?	N/A
N/A	X Walk 1 Width (In)	N/A	N/A	DWS 1 Length (In)	N/A
N/A	Road 1 Slope (%)	4.3	N/A	DWS 1 Full Width?	N/A
N/A	Road 1 X Slope (%)	1.5	N/A	DWS 1 Offset (In)	N/A
Yes	Refuge 2 Length (In)	37.0	N/A	Gutter 2 Ponding?	N/A
Yes	Refuge 2 Width (In)	173.0	N/A	Gutter 2 Lip Ht (In)	N/A
Yes	Refuge 2 Slope (%)	3.2	N/A	Gutter 2 Slope (%)	N/A
No	Refuge 2 X Slope (%)	5.2	N/A	Gutter 2 X Slope (%)	N/A
N/A	Painted X Walk2?	No	N/A	DWS 2 Provided?	N/A
N/A	X Walk 2 Direction	To S	N/A	DWS 2 Contrast?	N/A
N/A	X Walk 2 Width (In)	N/A	N/A	DWS 2 Length (In)	N/A

N/A	Road 2 Slope (%)	3.6	N/A	DWS 2 Full Width?	N/A
N/A	Road 2 X Slope (%)	6.9	N/A	DWS 2 Offset (In)	N/A
N/A	Refuge 3 Length (in)	N/A	N/A	Gutter 3 Ponding?	N/A
N/A	Refuge 3 Width (in)	N/A	N/A	Gutter 3 Lip Ht (in)	N/A
N/A	Refuge 3 Slope (%)	N/A	N/A	Gutter 3 Slope (%)	N/A
N/A	Refuge 3 XSlope (%)	N/A	N/A	Gutter 3 XSlope (%)	N/A
N/A	Painted X Walk3?	N/A	N/A	DWS 3 Provided?	N/A
N/A	X Walk 3 Direction	N/A	N/A	DWS 3 Contrast?	N/A
N/A	X Walk 3 Width (in)	N/A	N/A	DWS 3 Length (in)	N/A
N/A	Road 3 Slope (%)	N/A	N/A	DWS 3 Full Width?	N/A
N/A	Road 3 XSlope (%)	N/A	N/A	DWS 3 Offset (in)	N/A
Yes	Any Obstructions?	N/A	N/A	Storm Grate/Utility Hazard?	N/A
N/A	Obstruction Type		N/A	Storm Grate/Utility Type	
		N/A			N/A
N/A	Surface Condition	Good

Remove & Replace Entire Refuge.

\$ 3000.00
