Access Compliance Report

Public Rights-of-Way

(Island Curb Cuts)

Intersection ID: 53165	Main Street: DIXIE_RIVER_RD	Cross Street: STYLE_LN	Location: S
ADA ID: 2AE565D7629F	Curb Cut Type: MedianRefuge2	Initial Pass/Fail: Fail	Overall Compliance: No
Codes/Mitigation Info/Possible Solution		Field Measurements/Component Compliance

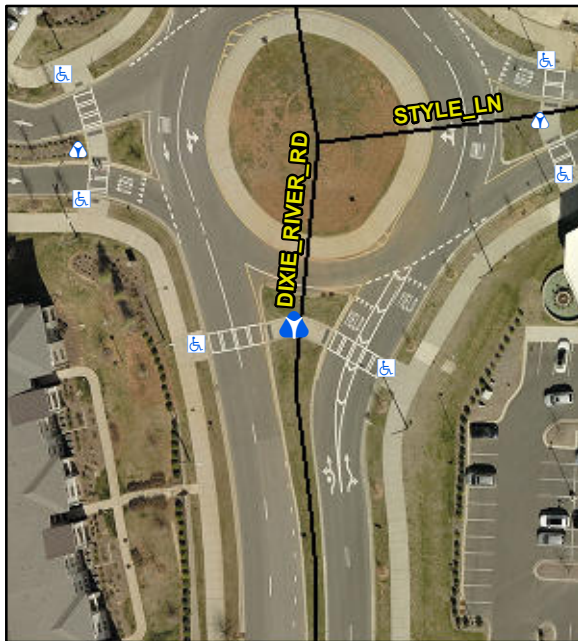
Compliance	Description	Data	Compliance	Description	Data
Yes	Refuge 1 Length (In)	187.5	N/A	Gutter 1 Ponding?	N/A
Yes	Refuge 1 Width (In)	105.5	N/A	Gutter 1 Lip Ht (In)	N/A
Yes	Refuge 1 Slope (%)	1.9	N/A	Gutter 1 Slope (%)	N/A
No	Refuge 1 X Slope (%)	5.1	N/A	Gutter 1 X Slope (%)	N/A
N/A	Painted X Walk1?	Yes	N/A	DWS 1 Provided?	N/A
N/A	X Walk 1 Direction	To SE	N/A	DWS 1 Contrast?	N/A
N/A	X Walk 1 Width (In)	112	N/A	DWS 1 Length (In)	N/A
N/A	Road 1 Slope (%)	2.5	N/A	DWS 1 Full Width?	N/A
N/A	Road 1 X Slope (%)	4.6	N/A	DWS 1 Offset (In)	N/A
Yes	Refuge 2 Length (In)	187.5	N/A	Gutter 2 Ponding?	N/A
Yes	Refuge 2 Width (In)	105.5	N/A	Gutter 2 Lip Ht (In)	N/A
Yes	Refuge 2 Slope (%)	1.3	N/A	Gutter 2 Slope (%)	N/A
Yes	Refuge 2 X Slope (%)	0.1	N/A	Gutter 2 X Slope (%)	N/A
N/A	Painted X Walk2?	Yes	N/A	DWS 2 Provided?	N/A
N/A	X Walk 2 Direction	To W	N/A	DWS 2 Contrast?	N/A
N/A	X Walk 2 Width (In)	112	N/A	DWS 2 Length (In)	N/A

Remove & Replace Entire Refuge.
