Access Compliance Report

Public Rights-of-Way

(Island Curb Cuts)

Intersection ID: 14741	Main Street: EAST_BV	Cross Street: PARK_RD	Location: NW
ADA ID: 2B3D2215FB9E	Curb Cut Type: MedianRefuge2	Initial Pass/Fail: Fail	Overall Compliance: No
Codes/Mitigation Info/Possible Solution		Field Measurements/Component Compliance	
Severity Score: 0

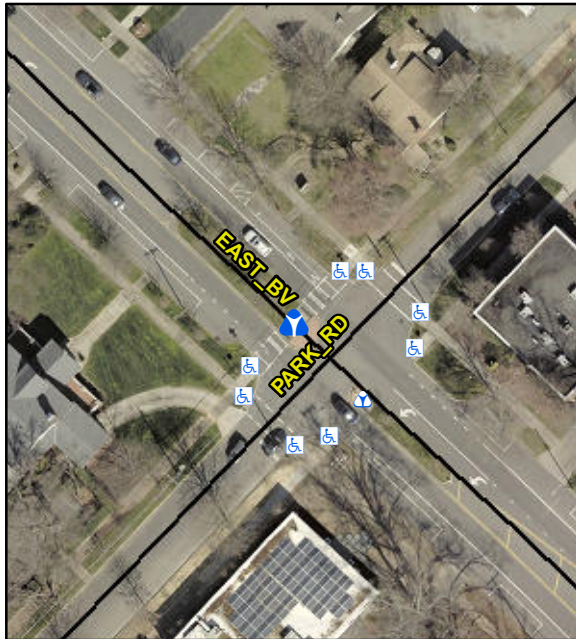
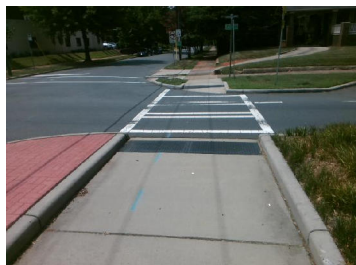
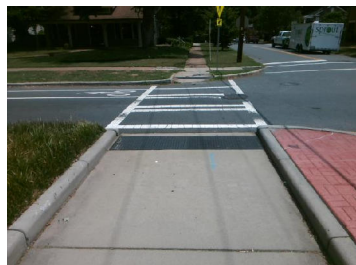
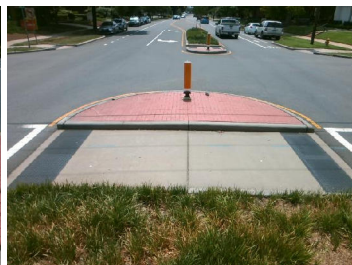
Compliance	Description	Data	Compliance	Description	Data
Yes	Refuge 1 Length (In)	111.0	N/A	Gutter 1 Ponding?	N/A
Yes	Refuge 1 Width (In)	98.0	N/A	Gutter 1 Lip Ht (In)	N/A
Yes	Refuge 1 Slope (%)	1.8	N/A	Gutter 1 Slope (%)	N/A
Yes	Refuge 1 X Slope (%)	4.2	N/A	Gutter 1 X Slope (%)	N/A
N/A	Painted X Walk1?	Yes	N/A	DWS 1 Provided?	N/A
N/A	X Walk 1 Direction	To SW	N/A	DWS 1 Contrast?	N/A
N/A	X Walk 1 Width (In)	112.0	N/A	DWS 1 Length (In)	N/A
N/A	Road 1 Slope (%)	0.3	N/A	DWS 1 Full Width?	N/A
N/A	Road 1 X Slope (%)	2.3	N/A	DWS 1 Offset (In)	N/A
Yes	Refuge 2 Length (In)	111.0	N/A	Gutter 2 Ponding?	N/A
Yes	Refuge 2 Width (In)	98.0	N/A	Gutter 2 Lip Ht (In)	N/A
Yes	Refuge 2 Slope (%)	0.8	N/A	Gutter 2 Slope (%)	N/A
Yes	Refuge 2 X Slope (%)	1.6	N/A	Gutter 2 X Slope (%)	N/A
N/A	Painted X Walk2?	No	N/A	DWS 2 Provided?	N/A
N/A	X Walk 2 Direction	To NE	N/A	DWS 2 Contrast?	N/A
N/A	X Walk 2 Width (In)	112.0	N/A	DWS 2 Length (In)	N/A

Remove & Replace Entire Refuge.
