Access Compliance Report Public Rights-of-Way (Island Curb Cuts)

Intersection ID: 10016647 Main Street: N TRYON ST **Cross Street: N/A** Location: N ADA ID: 2C9CF719625C Curb Cut Type: MedianRefuge2 Initial Pass/Fail: Fail **Overall Compliance: No Severity Score:** 0

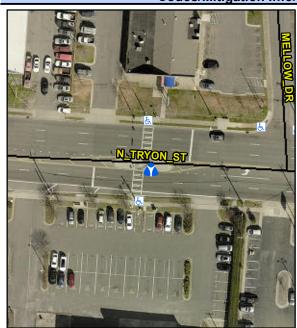
Yes	Refuge 1 X Slope (%)	3.4 N/	A	Gutter 1 X Slope (%)	N/A
N/A	Painted X Walk1?	No N/	Α	DWS 1 Provided?	N/A
N/A	X Walk 1 Direction	To S N/	Α	DWS 1 Contrast?	N/A
N/A	X Walk 1 Width (In)	N/A N/	Α	DWS 1 Length (In)	N/A
N/A	Road 1 Slope (%)	2.5 N/	Α	DWS 1 Full Width?	N/A
N/A	Road 1 X Slope (%)	0.9 N/A	Α	DWS 1 Offset (In)	N/A
Yes	Refuge 2 Length (In)	60.0 N/	Α	Gutter 2 Ponding?	N/A
Yes	Refuge 2 Width (In)	96.0 N/	Α	Gutter 2 Lip Ht (In)	N/A
Yes	Refuge 2 Slope (%)	0.3 N/	Α	Gutter 2 Slope (%)	N/A
Yes	Refuge 2 X Slope (%)	3.0 N/	Α	Gutter 2 X Slope (%)	N/A
N/A	Painted X Walk2?	No N/	Α	DWS 2 Provided?	N/A
N/A	X Walk 2 Direction	To N N/	A	DWS 2 Contrast?	N/A
N/A	X Walk 2 Width (In)	N/A N/	Α	DWS 2 Length (In)	N/A
N/A	Road 2 Slope (%)	2.2 N/	Α	DWS 2 Full Width?	N/A
N/A	Road 2 X Slope (%)	1.3 N/	Α	DWS 2 Offset (In)	N/A
N/A	Refuge 3 Length (in)	N/A N/	A	Gutter 3 Ponding?	N/A
N/A	Refuge 3 Width (in)	N/A N/	A	Gutter 3 Lip Ht (in)	N/A

Remove & Replace Entire Refuge. Surveyor Notes: N/A
