Access Compliance Report

Public Rights-of-Way

(Island Curb Cuts)

Intersection ID: 44555	Main Street: UNIVERSITY_CITY_BV	Cross Street: N_TRYON_ST	Location: NW
ADA ID: 2E7B83CDC582	Curb Cut Type: IslandRefuge3	Initial Pass/Fail: Fail	Overall Compliance: No
Codes/Mitigation Info/Possible Solution		Field Measurements/Component Compliance

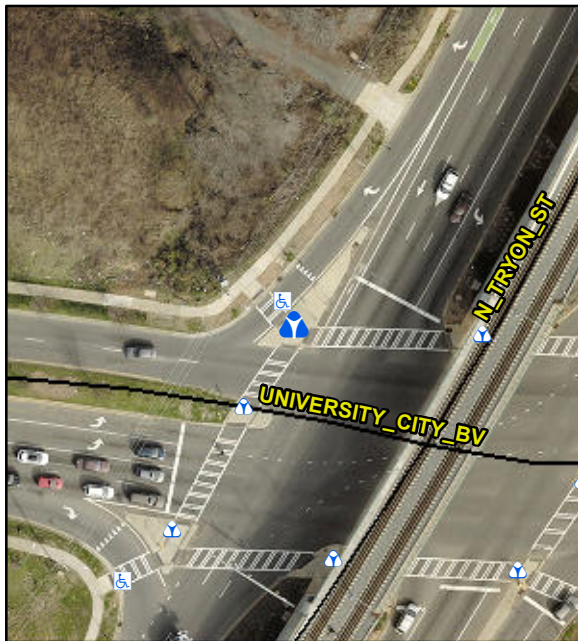
Compliance	Description	Data	Compliance	Description	Data
Yes	Refuge 1 Length (In)	36.0	Yes	Gutter 1 Ponding?	N/A
Yes	Refuge 1 Width (In)	108.0	No	Gutter 1 Lip Ht (In)	1.5
Yes	Refuge 1 Slope (%)	2.2	No	Gutter 1 Slope (%)	N/A
Yes	Refuge 1 X Slope (%)	2.4	No	Gutter 1 X Slope (%)	N/A
N/A	Painted X Walk1?	Yes	N/A	DWS 1 Provided?	N/A
N/A	X Walk 1 Direction	To E	N/A	DWS 1 Contrast?	N/A
N/A	X Walk 1 Width (In)	105.0	N/A	DWS 1 Length (In)	N/A
N/A	Road 1 Slope (%)	0.4	N/A	DWS 1 Full Width?	N/A
N/A	Road 1 X Slope (%)	0.4	N/A	DWS 1 Offset (In)	N/A
Yes	Refuge 2 Length (In)	48.0	Yes	Gutter 2 Ponding?	N/A
Yes	Refuge 2 Width (In)	104.0	No	Gutter 2 Lip Ht (In)	2.0
Yes	Refuge 2 Slope (%)	1.6	No	Gutter 2 Slope (%)	N/A
Yes	Refuge 2 X Slope (%)	2.7	No	Gutter 2 X Slope (%)	N/A
N/A	Painted X Walk2?	Yes	N/A	DWS 2 Provided?	N/A
N/A	X Walk 2 Direction	To SW	N/A	DWS 2 Contrast?	N/A
N/A	X Walk 2 Width (In)	124.5	N/A	DWS 2 Length (In)	N/A

N/A	Road 2 Slope (%)	2.2	N/A	DWS 2 Full Width?	N/A
N/A	Road 2 X Slope (%)	1.0	N/A	DWS 2 Offset (In)	N/A
Yes	Refuge 3 Length (in)	98.0	Yes	Gutter 3 Ponding?	N/A
Yes	Refuge 3 Width (in)	96.0	No	Gutter 3 Lip Ht (in)	2.0
Yes	Refuge 3 Slope (%)	1.3	No	Gutter 3 Slope (%)	N/A
Yes	Refuge 3 XSlope (%)	0.3	No	Gutter 3 XSlope (%)	N/A
N/A	Painted X Walk3?	Yes	N/A	DWS 3 Provided?	N/A
N/A	X Walk 3 Direction	To NW	N/A	DWS 3 Contrast?	N/A
N/A	X Walk 3 Width (in)	120.0	N/A	DWS 3 Length (in)	N/A
N/A	Road 3 Slope (%)	0.0	N/A	DWS 3 Full Width?	N/A
N/A	Road 3 XSlope (%)	3.0	N/A	DWS 3 Offset (in)	N/A
Yes	Any Obstructions?	N/A	N/A	Storm Grate/Utility Hazard?	N/A
N/A	Obstruction Type		N/A	Storm Grate/Utility Type	
		N/A			N/A
N/A	Surface Condition	Good

Remove & Replace Entire Refuge.
Remove & Replace Gutter.
