Access Compliance Report

Public Rights-of-Way

(Island Curb Cuts)

Intersection ID: 10015853	Main Street: STATESVILLE_AV	Cross Street: N/A	Location: N
ADA ID: 31B753864CA8	Curb Cut Type: MedianRefuge2	Initial Pass/Fail: Pass	Overall Compliance: No
Codes/Mitigation Info/Possible Solution		Field Measurements/Component Compliance

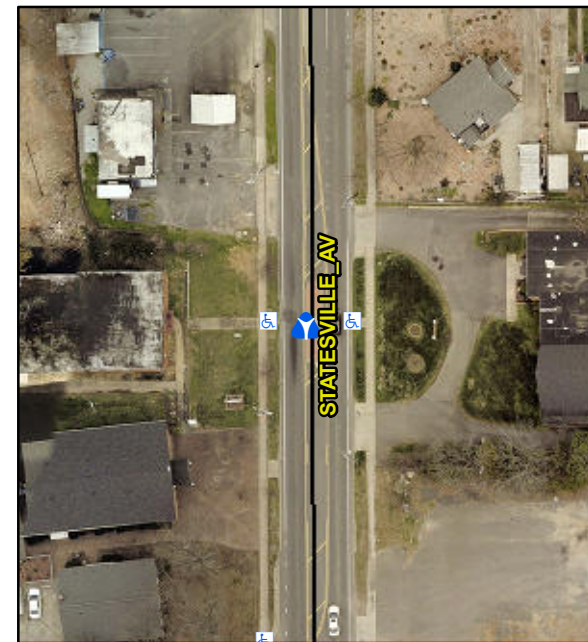
Compliance	Description	Data	Compliance	Description	Data
Yes	Refuge 1 Length (In)	54.0	Yes	Gutter 1 Ponding?	No
Yes	Refuge 1 Width (In)	99.0	No	Gutter 1 Lip Ht (In)	0.5
Yes	Refuge 1 Slope (%)	1.5	No	Gutter 1 Slope (%)	8.0
Yes	Refuge 1 X Slope (%)	0.2	Yes	Gutter 1 X Slope (%)	1.4
N/A	Painted X Walk1?	No	Yes	DWS 1 Provided?	Yes
N/A	X Walk 1 Direction	To W	Yes	DWS 1 Contrast?	Yes
N/A	X Walk 1 Width (In)	N/A	Yes	DWS 1 Length (In)	24.0
N/A	Road 1 Slope (%)	0.6	Yes	DWS 1 Full Width?	Yes
N/A	Road 1 X Slope (%)	3.8	No	DWS 1 Offset (In)	4.5
Yes	Refuge 2 Length (In)	54.0	Yes	Gutter 2 Ponding?	No
Yes	Refuge 2 Width (In)	99.0	Yes	Gutter 2 Lip Ht (In)	0.0
Yes	Refuge 2 Slope (%)	2.2	Yes	Gutter 2 Slope (%)	0.2
Yes	Refuge 2 X Slope (%)	1.8	No	Gutter 2 X Slope (%)	5.7
N/A	Painted X Walk2?	No	Yes	DWS 2 Provided?	Yes
N/A	X Walk 2 Direction	To E	Yes	DWS 2 Contrast?	Yes
N/A	X Walk 2 Width (In)	N/A	Yes	DWS 2 Length (In)	24.0
N/A	Road 2 Slope (%)	0.8	Yes	DWS 2 Full Width?	Yes

N/A	Road 2 X Slope (%)	5.6	No	DWS 2 Offset (In)	4.5
N/A	Refuge 3 Length (in)	N/A	N/A	Gutter 3 Ponding?	N/A
N/A	Refuge 3 Width (in)	N/A	N/A	Gutter 3 Lip Ht (in)	N/A
N/A	Refuge 3 Slope (%)	N/A	N/A	Gutter 3 Slope (%)	N/A
N/A	Refuge 3 XSlope (%)	N/A	N/A	Gutter 3 XSlope (%)	N/A
N/A	Painted X Walk3?	N/A	N/A	DWS 3 Provided?	N/A
N/A	X Walk 3 Direction	N/A	N/A	DWS 3 Contrast?	N/A
N/A	X Walk 3 Width (in)	N/A	N/A	DWS 3 Length (in)	N/A
N/A	Road 3 Slope (%)	N/A	N/A	DWS 3 Full Width?	N/A
N/A	Road 3 XSlope (%)	N/A	N/A	DWS 3 Offset (in)	N/A
Yes	Any Obstructions?	No	N/A	Storm Grate/Utility Hazard?	No
N/A	Obstruction Type		N/A	Storm Grate/Utility Type	
		N/A			N/A
N/A	Surface Condition	Good

Remove & Replace Detectable Warning System. Remove & Replace Gutter.
