# Access Compliance Report

## Public Rights-of-Way

### (Island Curb Cuts)

| Intersection ID: 11730 | Main Street: MECKLENBURG_AV | Cross Street: THE_PLAZA | Location: NE |

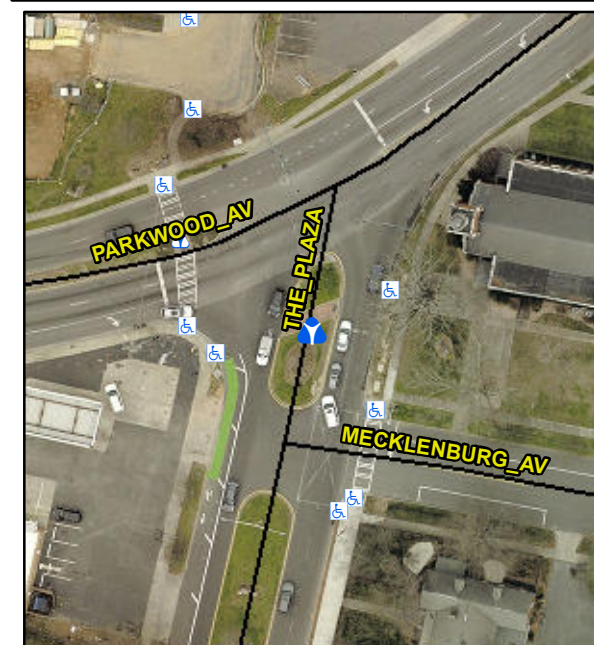
| ADA ID: 31E5ACC000F9 | Curb Cut Type: MedianRefuge2 | Initial Pass/Fail: Pass | Overall Compliance: No |
| Severity Score: 12.75 | | | |

| Compliance | Description | Data | Compliance | Description | Data |
|---|---|---|---|---|---|
| Yes | Refuge 1 Width (In) | 95.0 | No | Gutter 1 Lip Ht (In) | 0.5 |
| N/A | Road 1 Slope (%) | 1.4 | No | DWS 1 Full Width? | No |
| N/A | Road 1 X Slope (%) | 0.4 | No | DWS 1 Offset (In) | 5.0 |
| Yes | Refuge 2 Width (In) | 95.0 | No | Gutter 2 Lip Ht (In) | 0.5 |
| N/A | Road 2 Slope (%) | 1.5 | No | DWS 2 Full Width? | No |
| N/A | Road 2 X Slope (%) | 2.2 | No | DWS 2 Offset (In) | 2.5 |

**Remove & Replace Detectable Warning System. Remove & Replace Gutter.**
