Access Compliance Report

Public Rights-of-Way

(Island Curb Cuts)

Intersection ID: 7770	Main Street: E_ARROWHEAD_DR	Cross Street: N_TRYON_ST	Location:	S
ADA ID: 320B7040F369	Curb Cut Type: MedianRefuge2	Initial Pass/Fail: Pass	Overall Compliance: No	Severity Score: 15
Codes/Mitigation Info/Possible Solution		Field Measurements/Component Compliance

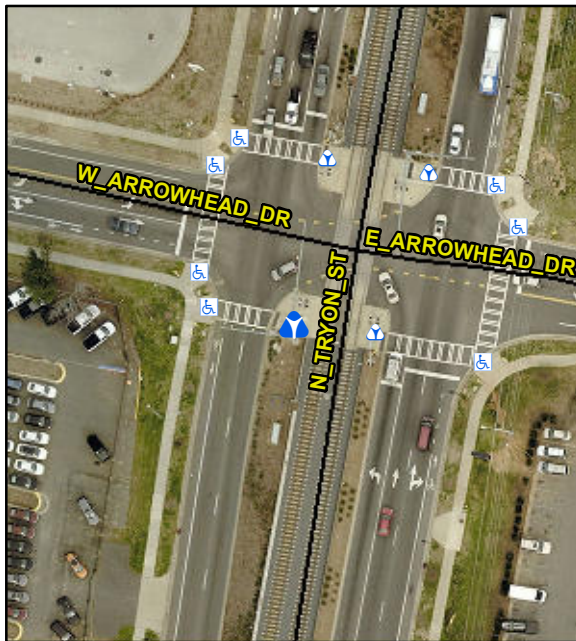
Compliance	Description	Data	Compliance	Description	Data
Yes	Refuge 1 Length (In)	96.0	Yes	Gutter 1 Ponding?	No
Yes	Refuge 1 Width (In)	120.0	No	Gutter 1 Lip Ht (In)	1.0
Yes	Refuge 1 Slope (%)	1.1	Yes	Gutter 1 Slope (%)	3.8
Yes	Refuge 1 X Slope (%)	0.6	Yes	Gutter 1 X Slope (%)	0.4
N/A	Painted X Walk1?	Yes	Yes	DWS 1 Provided?	Yes
N/A	X Walk 1 Direction	To W	Yes	DWS 1 Contrast?	Yes
N/A	X Walk 1 Width (In)	119.0	Yes	DWS 1 Length (In)	24.0
N/A	Road 1 Slope (%)	1.2	Yes	DWS 1 Full Width?	Yes
N/A	Road 1 X Slope (%)	2.3	No	DWS 1 Offset (In)	5.0
Yes	Refuge 2 Length (In)	109.0	Yes	Gutter 2 Ponding?	No
Yes	Refuge 2 Width (In)	120.0	Yes	Gutter 2 Lip Ht (In)	0.0
Yes	Refuge 2 Slope (%)	0.3	Yes	Gutter 2 Slope (%)	4.0
Yes	Refuge 2 X Slope (%)	0.2	Yes	Gutter 2 X Slope (%)	1.3
N/A	Painted X Walk2?	No	Yes	DWS 2 Provided?	Yes
N/A	X Walk 2 Direction	To E	Yes	DWS 2 Contrast?	Yes
N/A	X Walk 2 Width (In)	N/A	Yes	DWS 2 Length (In)	24.0

Remove & Replace Detectable Warning System. Grind Gutter Lip. Utility Present.

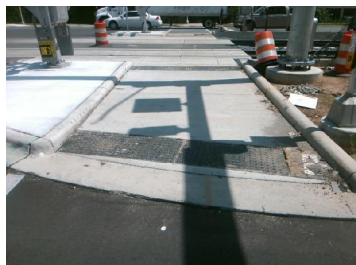
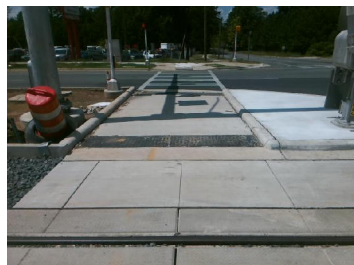
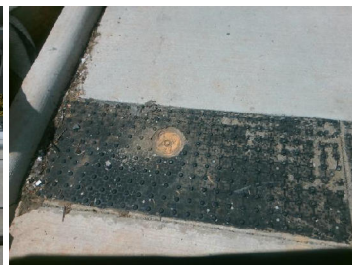
GAS VAL R2 DWS LIP 0.5"
