Access Compliance Report

Public Rights-of-Way

(Island Curb Cuts)

Intersection ID: 48168	Main Street: PERIMETER_PY	Cross Street: NORTHLAKE_MALL_DR	Location: S
ADA ID: 32BDEA15B92A	Curb Cut Type: MedianRefuge2	Initial Pass/Fail: Fail	Overall Compliance: No
Codes/Mitigation Info/Possible Solution		Field Measurements/Component Compliance	
Severity Score: 0

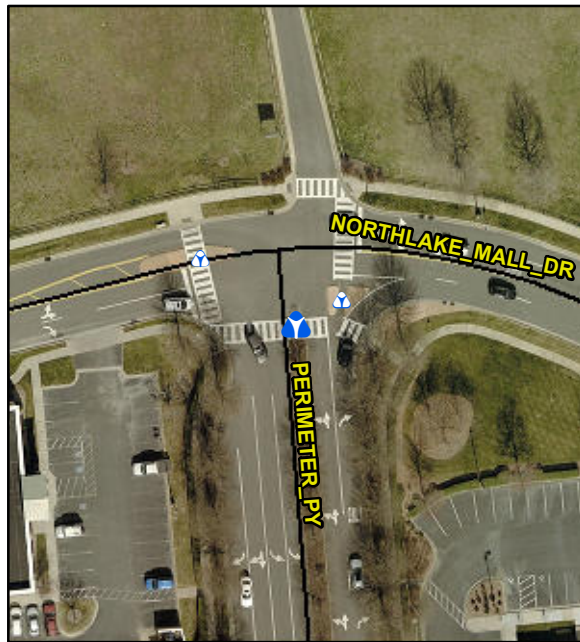
Compliance	Description	Data	Compliance	Description	Data
Yes	Refuge 1 Length (In)	39.0	N/A	Gutter 1 Ponding?	N/A
Yes	Refuge 1 Width (In)	125.0	N/A	Gutter 1 Lip Ht (In)	N/A
Yes	Refuge 1 Slope (%)	1.7	N/A	Gutter 1 Slope (%)	N/A
Yes	Refuge 1 X Slope (%)	3.3	N/A	Gutter 1 X Slope (%)	N/A
N/A	Painted X Walk1?	Yes	N/A	DWS 1 Provided?	N/A
N/A	X Walk 1 Direction	To E	N/A	DWS 1 Contrast?	N/A
N/A	X Walk 1 Width (In)	96.0	N/A	DWS 1 Length (In)	N/A
N/A	Road 1 Slope (%)	5.6	N/A	DWS 1 Full Width?	N/A
N/A	Road 1 X Slope (%)	0.3	N/A	DWS 1 Offset (In)	N/A
Yes	Refuge 2 Length (In)	39.0	N/A	Gutter 2 Ponding?	N/A
Yes	Refuge 2 Width (In)	125.0	N/A	Gutter 2 Lip Ht (In)	N/A
Yes	Refuge 2 Slope (%)	0.6	N/A	Gutter 2 Slope (%)	N/A
Yes	Refuge 2 X Slope (%)	2.9	N/A	Gutter 2 X Slope (%)	N/A
N/A	Painted X Walk2?	Yes	N/A	DWS 2 Provided?	N/A
N/A	X Walk 2 Direction	To W	N/A	DWS 2 Contrast?	N/A
N/A	X Walk 2 Width (In)	98.0	N/A	DWS 2 Length (In)	N/A

N/A	Road 2 Slope (%)	2.0	N/A	DWS 2 Full Width?	N/A
N/A	Road 2 X Slope (%)	0.7	N/A	DWS 2 Offset (In)	N/A
N/A	Refuge 3 Length (in)	N/A	N/A	Gutter 3 Ponding?	N/A
N/A	Refuge 3 Width (in)	N/A	N/A	Gutter 3 Lip Ht (in)	N/A
N/A	Refuge 3 Slope (%)	N/A	N/A	Gutter 3 Slope (%)	N/A
N/A	Refuge 3 XSlope (%)	N/A	N/A	Gutter 3 XSlope (%)	N/A
N/A	Painted X Walk3?	N/A	N/A	DWS 3 Provided?	N/A
N/A	X Walk 3 Direction	N/A	N/A	DWS 3 Contrast?	N/A
N/A	X Walk 3 Width (in)	N/A	N/A	DWS 3 Length (in)	N/A
N/A	Road 3 Slope (%)	N/A	N/A	DWS 3 Full Width?	N/A
N/A	Road 3 XSlope (%)	N/A	N/A	DWS 3 Offset (in)	N/A
Yes	Any Obstructions?	N/A	N/A	Storm Grate/Utility Hazard?	N/A
N/A	Obstruction Type		N/A	Storm Grate/Utility Type	
		N/A			N/A
N/A	Surface Condition	Good

Possible Solutions:

Remove & Replace Entire Refuge.
