# Access Compliance Report

## Public Rights-of-Way

### (Island Curb Cuts)

Intersection ID: 52893	Main Street: TWITTER_LN	Cross Street: SANCTUARY_PL	Location: S
ADA ID: 333EB4320FD0	Curb Cut Type: MedianRefuge2	Initial Pass/Fail: Fail	Overall Compliance: No
Codes/Mitigation Info/Possible Solution		Field Measurements/Component Compliance

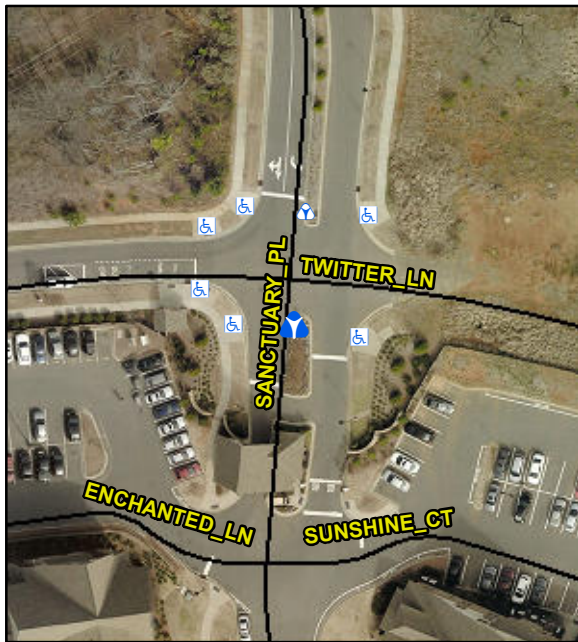
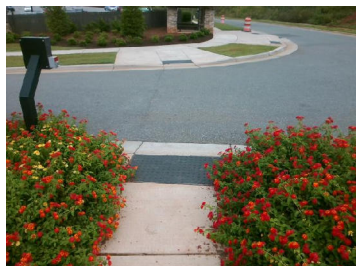
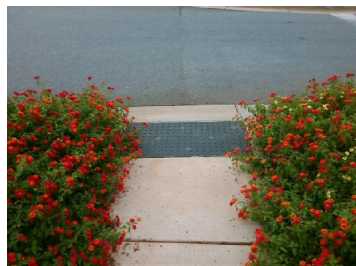
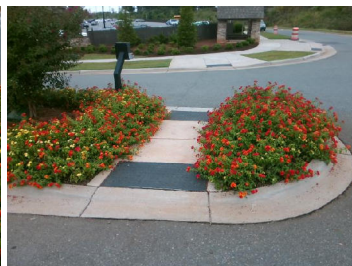
Compliance	Description	Data	Compliance	Description	Data
Yes	Refuge 1 Length (In)	58.0	N/A	Gutter 1 Ponding?	N/A
No	Refuge 1 Width (In)	30.5	N/A	Gutter 1 Lip Ht (In)	N/A
Yes	Refuge 1 Slope (%)	1.7	N/A	Gutter 1 Slope (%)	N/A
Yes	Refuge 1 X Slope (%)	4.1	N/A	Gutter 1 X Slope (%)	N/A
N/A	Painted X Walk1?	No	N/A	DWS 1 Provided?	N/A
N/A	X Walk 1 Direction	To W	N/A	DWS 1 Contrast?	N/A
N/A	X Walk 1 Width (In)	N/A	N/A	DWS 1 Length (In)	N/A
N/A	Road 1 Slope (%)	5.3	N/A	DWS 1 Full Width?	N/A
N/A	Road 1 X Slope (%)	2.9	N/A	DWS 1 Offset (In)	N/A
Yes	Refuge 2 Length (In)	58.0	N/A	Gutter 2 Ponding?	N/A
No	Refuge 2 Width (In)	30.5	N/A	Gutter 2 Lip Ht (In)	N/A
Yes	Refuge 2 Slope (%)	2.2	N/A	Gutter 2 Slope (%)	N/A
Yes	Refuge 2 X Slope (%)	3.8	N/A	Gutter 2 X Slope (%)	N/A
N/A	Painted X Walk2?	No	N/A	DWS 2 Provided?	N/A
N/A	X Walk 2 Direction	To E	N/A	DWS 2 Contrast?	N/A
N/A	X Walk 2 Width (In)	N/A	N/A	DWS 2 Length (In)	N/A

N/A	Road 2 Slope (%)	6.1	N/A	DWS 2 Full Width?	N/A
N/A	Road 2 X Slope (%)	3.5	N/A	DWS 2 Offset (In)	N/A
N/A	Refuge 3 Length (in)	N/A	N/A	Gutter 3 Ponding?	N/A
N/A	Refuge 3 Width (in)	N/A	N/A	Gutter 3 Lip Ht (in)	N/A
N/A	Refuge 3 Slope (%)	N/A	N/A	Gutter 3 Slope (%)	N/A
N/A	Refuge 3 XSlope (%)	N/A	N/A	Gutter 3 XSlope (%)	N/A
N/A	Painted X Walk3?	No	N/A	DWS 3 Provided?	N/A
N/A	X Walk 3 Direction	N/A	N/A	DWS 3 Contrast?	N/A
N/A	X Walk 3 Width (in)	N/A	N/A	DWS 3 Length (in)	N/A
N/A	Road 3 Slope (%)	N/A	N/A	DWS 3 Full Width?	N/A
N/A	Road 3 XSlope (%)	N/A	N/A	DWS 3 Offset (in)	N/A
Yes	Any Obstructions?	N/A	N/A	Storm Grate/Utility Hazard?	N/A
N/A	Obstruction Type		N/A	Storm Grate/Utility Type	
		N/A			N/A
N/A	Surface Condition	Good

**Remove & Replace Entire Refuge.**

**\$ 3000.00**
