# Access Compliance Report

## Public Rights-of-Way

### (Island Curb Cuts)

Intersection ID: 5967	Main Street: N_TRYON_ST	Cross Street: MCCULLOUGH_DR	Location: SE
ADA ID: 357C5B7FB8B6	Curb Cut Type: MedianRefuge2	Initial Pass/Fail: Fail	Overall Compliance: No
Codes/Mitigation Info/Possible Solution		Field Measurements/Component Compliance	
Severity Score: 1.25

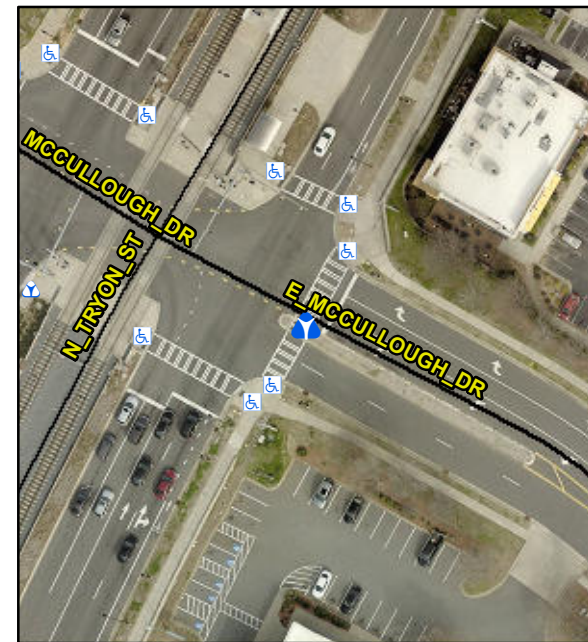
Compliance	Description	Data	Compliance	Description	Data
No	Refuge 1 Length (In)	33.0	Yes	Gutter 1 Ponding?	N/A
Yes	Refuge 1 Width (In)	119.5	No	Gutter 1 Lip Ht (In)	2.0
Yes	Refuge 1 Slope (%)	4.8	No	Gutter 1 Slope (%)	N/A
Yes	Refuge 1 X Slope (%)	3.8	No	Gutter 1 X Slope (%)	N/A
N/A	Painted X Walk1?	Yes	N/A	DWS 1 Provided?	N/A
N/A	X Walk 1 Direction	To SW	N/A	DWS 1 Contrast?	N/A
N/A	X Walk 1 Width (In)	120.5	N/A	DWS 1 Length (In)	N/A
N/A	Road 1 Slope (%)	3.3	N/A	DWS 1 Full Width?	N/A
N/A	Road 1 X Slope (%)	0.7	N/A	DWS 1 Offset (In)	N/A
No	Refuge 2 Length (In)	33.0	Yes	Gutter 2 Ponding?	N/A
Yes	Refuge 2 Width (In)	119.5	No	Gutter 2 Lip Ht (In)	2.5
Yes	Refuge 2 Slope (%)	0.5	No	Gutter 2 Slope (%)	N/A
Yes	Refuge 2 X Slope (%)	1.8	No	Gutter 2 X Slope (%)	N/A
N/A	Painted X Walk2?	Yes	N/A	DWS 2 Provided?	N/A
N/A	X Walk 2 Direction	To NE	N/A	DWS 2 Contrast?	N/A
N/A	X Walk 2 Width (In)	119.5	N/A	DWS 2 Length (In)	N/A

N/A	Road 2 Slope (%)	3.5	N/A	DWS 2 Full Width?	N/A
N/A	Road 2 X Slope (%)	2.4	N/A	DWS 2 Offset (In)	N/A
N/A	Refuge 3 Length (in)	N/A	N/A	Gutter 3 Ponding?	N/A
N/A	Refuge 3 Width (in)	N/A	N/A	Gutter 3 Lip Ht (in)	N/A
N/A	Refuge 3 Slope (%)	N/A	N/A	Gutter 3 Slope (%)	N/A
N/A	Refuge 3 XSlope (%)	N/A	N/A	Gutter 3 XSlope (%)	N/A
N/A	Painted X Walk3?	No	N/A	DWS 3 Provided?	N/A
N/A	X Walk 3 Direction	N/A	N/A	DWS 3 Contrast?	N/A
N/A	X Walk 3 Width (in)	N/A	N/A	DWS 3 Length (in)	N/A
N/A	Road 3 Slope (%)	N/A	N/A	DWS 3 Full Width?	N/A
N/A	Road 3 XSlope (%)	N/A	N/A	DWS 3 Offset (in)	N/A
Yes	Any Obstructions?	N/A	N/A	Storm Grate/Utility Hazard?	N/A
N/A	Obstruction Type		N/A	Storm Grate/Utility Type	
		N/A			N/A
N/A	Surface Condition	Good

**Remove & Replace Entire Refuge.**  
**Remove & Replace Gutter.**
