Access Compliance Report

Public Rights-of-Way

(Island Curb Cuts)

| Intersection ID: 23966 | Main Street: CAROLINA PAVILION DR_N | Cross Street: SOUTH BV | Location: SW |

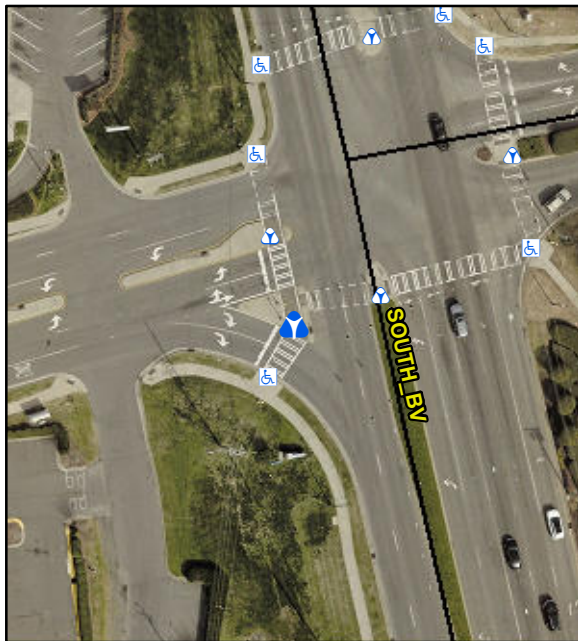
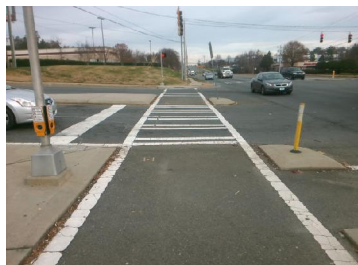
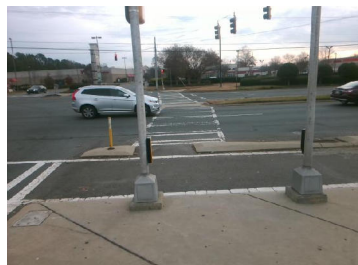
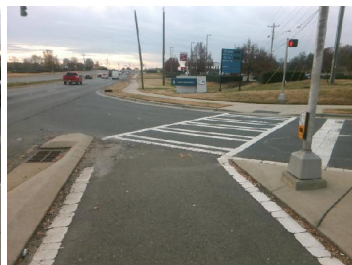
| ADA ID: 362CA56AB464 | Curb Cut Type: IslandRefuge3 | Initial Pass/Fail: Fail | Overall Compliance: No |
| Severity Score: 47.5 | | | |

| Compliance | Description | Data | Compliance | Description | Data |
|---|---|---|---|---|---|
| No | Refuge 3 Slope (%) | 5.6 | N/A | Gutter 3 Slope (%) | N/A |

Remove & Replace Entire Refuge.
