Access Compliance Report

Public Rights-of-Way

(Island Curb Cuts)

Intersection ID: 52765	Main Street: SHOPTON_RD	Cross Street: OUTLETS_BV	Location: S
ADA ID: 368267FD5733	Curb Cut Type: MedianRefuge2	Initial Pass/Fail: Fail	Overall Compliance: No
Codes/Mitigation Info/Possible Solution		Field Measurements/Component Compliance

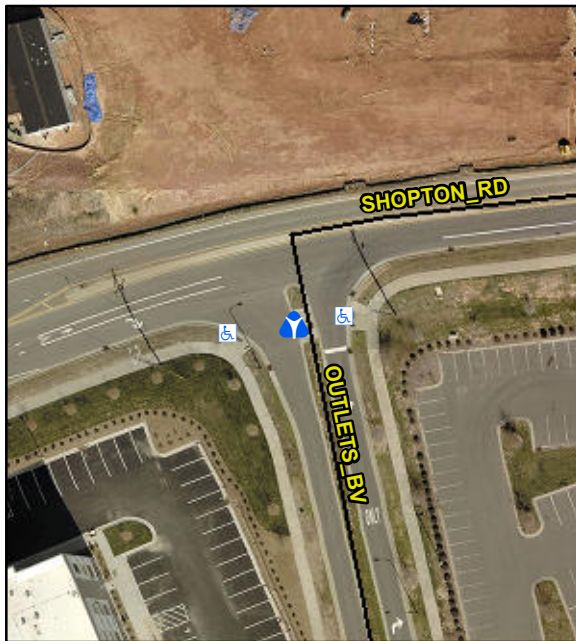
Compliance	Description	Data	Compliance	Description	Data
Yes	Refuge 1 Length (In)	47	N/A	Gutter 1 Ponding?	N/A
No	Refuge 1 Width (In)	47.5	N/A	Gutter 1 Lip Ht (In)	N/A
Yes	Refuge 1 Slope (%)	4.3	N/A	Gutter 1 Slope (%)	N/A
Yes	Refuge 1 X Slope (%)	3.4	N/A	Gutter 1 X Slope (%)	N/A
N/A	Painted X Walk1?	No	N/A	DWS 1 Provided?	N/A
N/A	X Walk 1 Direction	To E	N/A	DWS 1 Contrast?	N/A
N/A	X Walk 1 Width (In)	N/A	N/A	DWS 1 Length (In)	N/A
N/A	Road 1 Slope (%)	4.0	N/A	DWS 1 Full Width?	N/A
N/A	Road 1 X Slope (%)	2.0	N/A	DWS 1 Offset (In)	N/A
Yes	Refuge 2 Length (In)	47	N/A	Gutter 2 Ponding?	N/A
No	Refuge 2 Width (In)	47.5	N/A	Gutter 2 Lip Ht (In)	N/A
Yes	Refuge 2 Slope (%)	0.4	N/A	Gutter 2 Slope (%)	N/A
Yes	Refuge 2 X Slope (%)	3.3	N/A	Gutter 2 X Slope (%)	N/A
N/A	Painted X Walk2?	No	N/A	DWS 2 Provided?	N/A
N/A	X Walk 2 Direction	To W	N/A	DWS 2 Contrast?	N/A
N/A	X Walk 2 Width (In)	N/A	N/A	DWS 2 Length (In)	N/A
N/A	Road 2 Slope (%)	1.7	N/A	DWS 2 Full Width?	N/A

N/A	Road 2 X Slope (%)	2.3	N/A	DWS 2 Offset (In)	N/A
N/A	Refuge 3 Length (in)	N/A	N/A	Gutter 3 Ponding?	N/A
N/A	Refuge 3 Width (in)	N/A	N/A	Gutter 3 Lip Ht (in)	N/A
N/A	Refuge 3 Slope (%)	N/A	N/A	Gutter 3 Slope (%)	N/A
N/A	Refuge 3 XSlope (%)	N/A	N/A	Gutter 3 XSlope (%)	N/A
N/A	Painted X Walk3?	N/A	N/A	DWS 3 Provided?	N/A
N/A	X Walk 3 Direction	N/A	N/A	DWS 3 Contrast?	N/A
N/A	X Walk 3 Width (in)	N/A	N/A	DWS 3 Length (in)	N/A
N/A	Road 3 Slope (%)	N/A	N/A	DWS 3 Full Width?	N/A
N/A	Road 3 XSlope (%)	N/A	N/A	DWS 3 Offset (in)	N/A
Yes	Any Obstructions?	N/A	N/A	Storm Grate/Utility Hazard?	N/A
N/A	Obstruction Type		N/A	Storm Grate/Utility Type	
			N/A		N/A
N/A	Surface Condition	Good

Remove & Replace Entire Refuge.
