Access Compliance Report

Public Rights-of-Way

(Island Curb Cuts)

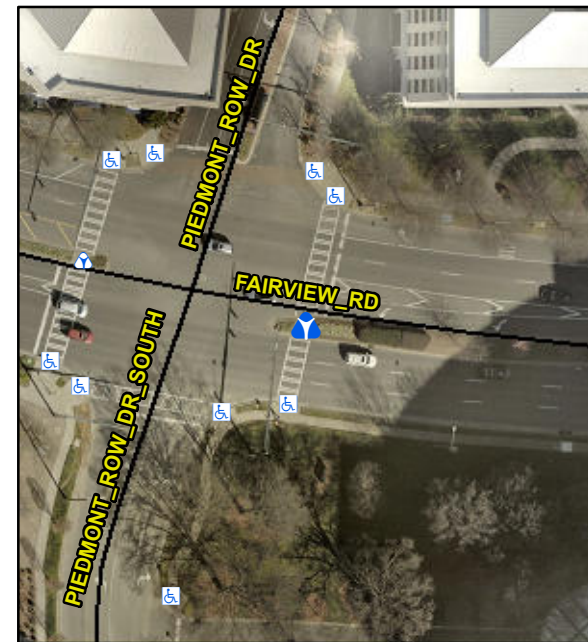
Intersection ID: 20185	Main Street: FAIRVIEW_RD	Cross Street: PIEDMONT_ROW_DR	Location: SE
ADA ID: 3787DB84157B	Curb Cut Type: MedianRefuge2	Initial Pass/Fail: Fail	Overall Compliance: No
Codes/Mitigation Info/Possible Solution		Field Measurements/Component Compliance	
Severity Score: 1.25

Possible Solutions:

Remove & Replace Entire Refuge.
