# Access Compliance Report

## Public Rights-of-Way

### (Island Curb Cuts)

Intersection ID: 28304	Main Street: LANCASTER_HY	Cross Street: JOHNSTON_RD	Location: NW
ADA ID: 37E188321F00	Curb Cut Type: MedianRefuge2	Initial Pass/Fail: Pass	Overall Compliance: No
Severity Score: 0.25			
Codes/Mitigation Info/Possible Solution		Field Measurements/Component Compliance

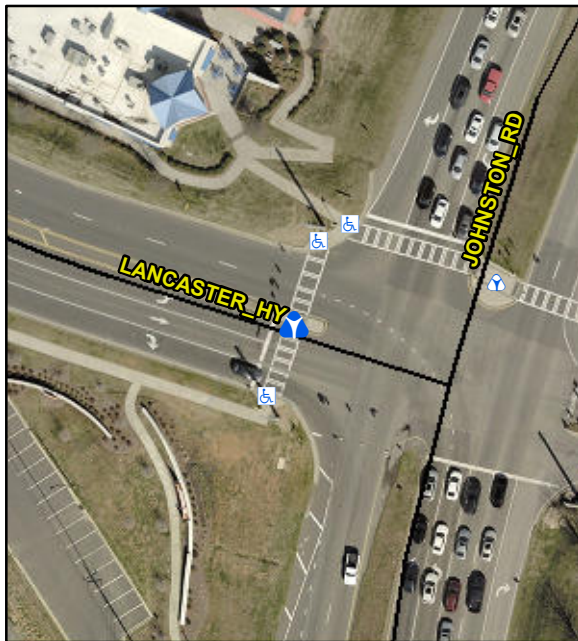
Compliance	Description	Data	Compliance	Description	Data
Yes	Refuge 1 Length (In)	36.75	Yes	Gutter 1 Ponding?	No
Yes	Refuge 1 Width (In)	119.0	Yes	Gutter 1 Lip Ht (In)	0.0
Yes	Refuge 1 Slope (%)	4.4	Yes	Gutter 1 Slope (%)	4.2
Yes	Refuge 1 X Slope (%)	0.4	Yes	Gutter 1 X Slope (%)	0.3
N/A	Painted X Walk1?	Yes	Yes	DWS 1 Provided?	Yes
N/A	X Walk 1 Direction	To NW	Yes	DWS 1 Contrast?	Yes
N/A	X Walk 1 Width (In)	104.0	Yes	DWS 1 Length (In)	24.0
N/A	Road 1 Slope (%)	0.2	Yes	DWS 1 Full Width?	Yes
N/A	Road 1 X Slope (%)	4.2	No	DWS 1 Offset (In)	12.0
Yes	Refuge 2 Length (In)	36.75	Yes	Gutter 2 Ponding?	No
Yes	Refuge 2 Width (In)	119.0	Yes	Gutter 2 Lip Ht (In)	0.0
Yes	Refuge 2 Slope (%)	3.8	Yes	Gutter 2 Slope (%)	2.1
Yes	Refuge 2 X Slope (%)	0.1	Yes	Gutter 2 X Slope (%)	0.2
N/A	Painted X Walk2?	Yes	Yes	DWS 2 Provided?	Yes
N/A	X Walk 2 Direction	To SE	Yes	DWS 2 Contrast?	Yes
N/A	X Walk 2 Width (In)	103.0	Yes	DWS 2 Length (In)	24.0

N/A	Road 2 Slope (%)	0.2	Yes	DWS 2 Full Width?	Yes
N/A	Road 2 X Slope (%)	2.9	No	DWS 2 Offset (In)	12.0
N/A	Refuge 3 Length (in)	N/A	N/A	Gutter 3 Ponding?	N/A
N/A	Refuge 3 Width (in)	N/A	N/A	Gutter 3 Lip Ht (in)	N/A
N/A	Refuge 3 Slope (%)	N/A	N/A	Gutter 3 Slope (%)	N/A
N/A	Refuge 3 XSlope (%)	N/A	N/A	Gutter 3 XSlope (%)	N/A
N/A	Painted X Walk3?	N/A	N/A	DWS 3 Provided?	N/A
N/A	X Walk 3 Direction	N/A	N/A	DWS 3 Contrast?	N/A
N/A	X Walk 3 Width (in)	N/A	N/A	DWS 3 Length (in)	N/A
N/A	Road 3 Slope (%)	N/A	N/A	DWS 3 Full Width?	N/A
N/A	Road 3 XSlope (%)	N/A	N/A	DWS 3 Offset (in)	N/A
Yes	Any Obstructions?	N/A	N/A	Storm Grate/Utility Hazard?	No
N/A	Obstruction Type		N/A	Storm Grate/Utility Type	
		N/A			N/A
N/A	Surface Condition	Good

**Remove & Replace Detectable Warning System.**
