# Access Compliance Report

## Public Rights-of-Way

### (Island Curb Cuts)

Intersection ID: 46810	Main Street: ARBOR_VISTA_DR	Cross Street: CLAUDE_FREEMAN_DR	Location: N
ADA ID: 3803D1316689	Curb Cut Type: MedianRefuge2	Initial Pass/Fail: Fail	Overall Compliance: No
Codes/Mitigation Info/Possible Solution		Field Measurements/Component Compliance	
Severity Score: 0

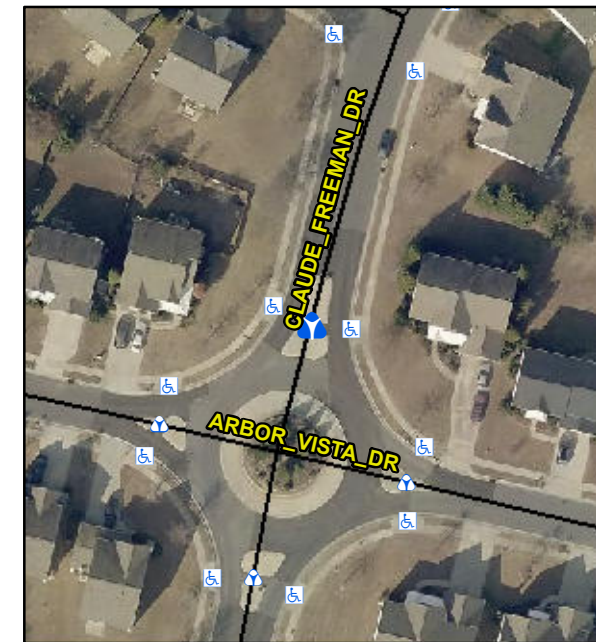
Compliance	Description	Data	Compliance	Description	Data
Yes	Refuge 1 Length (In)	78.0	N/A	Gutter 1 Ponding?	N/A
Yes	Refuge 1 Width (In)	64.0	N/A	Gutter 1 Lip Ht (In)	N/A
Yes	Refuge 1 Slope (%)	0.1	N/A	Gutter 1 Slope (%)	N/A
Yes	Refuge 1 X Slope (%)	3.8	N/A	Gutter 1 X Slope (%)	N/A
N/A	Painted X Walk1?	No	N/A	DWS 1 Provided?	N/A
N/A	X Walk 1 Direction	To E	N/A	DWS 1 Contrast?	N/A
N/A	X Walk 1 Width (In)	N/A	N/A	DWS 1 Length (In)	N/A
N/A	Road 1 Slope (%)	2.2	N/A	DWS 1 Full Width?	N/A
N/A	Road 1 X Slope (%)	2.1	N/A	DWS 1 Offset (In)	N/A
Yes	Refuge 2 Length (In)	78.0	N/A	Gutter 2 Ponding?	N/A
Yes	Refuge 2 Width (In)	64.0	N/A	Gutter 2 Lip Ht (In)	N/A
Yes	Refuge 2 Slope (%)	0.1	N/A	Gutter 2 Slope (%)	N/A
Yes	Refuge 2 X Slope (%)	4.2	N/A	Gutter 2 X Slope (%)	N/A
N/A	Painted X Walk2?	No	N/A	DWS 2 Provided?	N/A
N/A	X Walk 2 Direction	To W	N/A	DWS 2 Contrast?	N/A
N/A	X Walk 2 Width (In)	N/A	N/A	DWS 2 Length (In)	N/A

N/A	Road 2 Slope (%)	5.5	N/A	DWS 2 Full Width?	N/A
N/A	Road 2 X Slope (%)	5.0	N/A	DWS 2 Offset (In)	N/A
N/A	Refuge 3 Length (in)	N/A	N/A	Gutter 3 Ponding?	N/A
N/A	Refuge 3 Width (in)	N/A	N/A	Gutter 3 Lip Ht (in)	N/A
N/A	Refuge 3 Slope (%)	N/A	N/A	Gutter 3 Slope (%)	N/A
N/A	Refuge 3 XSlope (%)	N/A	N/A	Gutter 3 XSlope (%)	N/A
N/A	Painted X Walk3?	No	N/A	DWS 3 Provided?	N/A
N/A	X Walk 3 Direction	N/A	N/A	DWS 3 Contrast?	N/A
N/A	X Walk 3 Width (in)	N/A	N/A	DWS 3 Length (in)	N/A
N/A	Road 3 Slope (%)	N/A	N/A	DWS 3 Full Width?	N/A
N/A	Road 3 XSlope (%)	N/A	N/A	DWS 3 Offset (in)	N/A
Yes	Any Obstructions?	N/A	N/A	Storm Grate/Utility Hazard?	N/A
N/A	Obstruction Type		N/A	Storm Grate/Utility Type	
		N/A			N/A
N/A	Surface Condition	Good

**Remove & Replace Entire Refuge.**

**\$ 3000.00**
