Access Compliance Report

Public Rights-of-Way

(Island Curb Cuts)

Intersection ID: 42988	Main Street: UNIVERSITY_CITY_BV	Cross Street: UNIVERSITY_WALK_CR	Location:	W
ADA ID: 38FBB0215ACE	Curb Cut Type: MedianRefuge2	Initial Pass/Fail: Fail	Overall Compliance: No	Severity Score: 25
Codes/Mitigation Info/Possible Solution		Field Measurements/Component Compliance

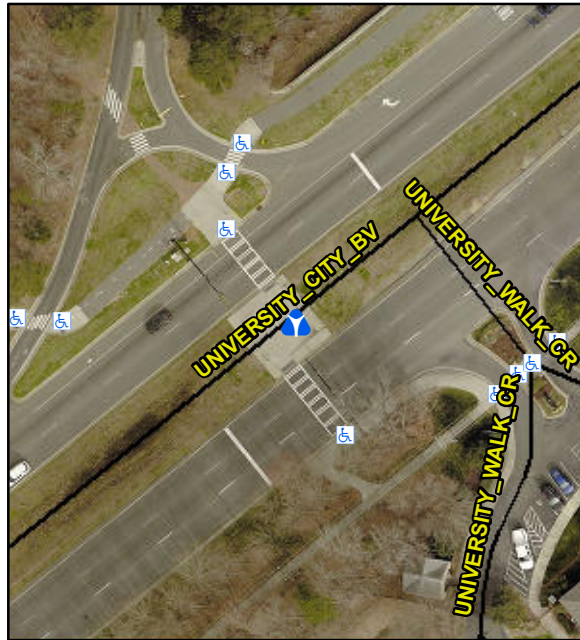
Compliance	Description	Data	Compliance	Description	Data
Yes	Refuge 1 Length (In)	60.0	N/A	Gutter 1 Ponding?	N/A
Yes	Refuge 1 Width (In)	100.0	N/A	Gutter 1 Lip Ht (In)	N/A
No	Refuge 1 Slope (%)	8.5	N/A	Gutter 1 Slope (%)	N/A
Yes	Refuge 1 X Slope (%)	0.3	N/A	Gutter 1 X Slope (%)	N/A
N/A	Painted X Walk1?	Yes	N/A	DWS 1 Provided?	N/A
N/A	X Walk 1 Direction	To SE	N/A	DWS 1 Contrast?	N/A
N/A	X Walk 1 Width (In)	111.0	N/A	DWS 1 Length (In)	N/A
N/A	Road 1 Slope (%)	0.1	N/A	DWS 1 Full Width?	N/A
N/A	Road 1 X Slope (%)	3.0	N/A	DWS 1 Offset (In)	N/A
Yes	Refuge 2 Length (In)	60.0	N/A	Gutter 2 Ponding?	N/A
Yes	Refuge 2 Width (In)	100.0	N/A	Gutter 2 Lip Ht (In)	N/A
Yes	Refuge 2 Slope (%)	0.9	N/A	Gutter 2 Slope (%)	N/A
Yes	Refuge 2 X Slope (%)	0.3	N/A	Gutter 2 X Slope (%)	N/A
N/A	Painted X Walk2?	Yes	N/A	DWS 2 Provided?	N/A
N/A	X Walk 2 Direction	To NW	N/A	DWS 2 Contrast?	N/A
N/A	X Walk 2 Width (In)	112.0	N/A	DWS 2 Length (In)	N/A

Remove & Replace Entire Refuge.
