# Access Compliance Report

## Public Rights-of-Way

### (Island Curb Cuts)

Intersection ID: 30548	Main Street: SOUTH_BV	Cross Street: N/A	Location: W
ADA ID: 3956D2D74B53	Curb Cut Type: MedianRefuge2	Initial Pass/Fail: Fail	Overall Compliance: No
Codes/Mitigation Info/Possible Solution		Field Measurements/Component Compliance

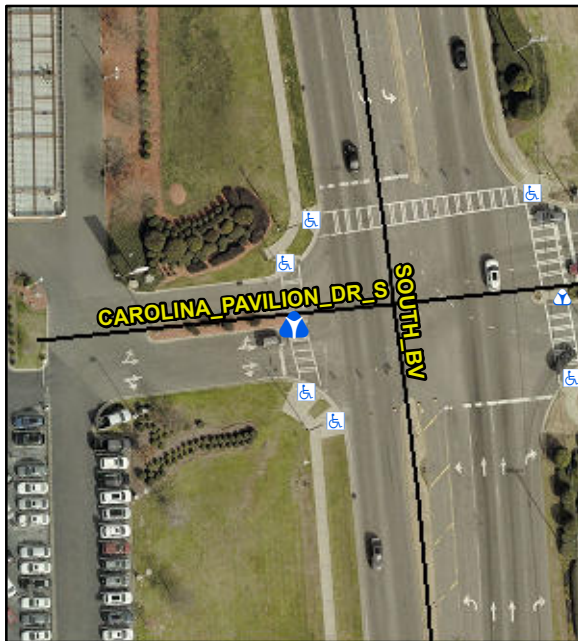
Compliance	Description	Data	Compliance	Description	Data
No	Refuge 1 Length (In)	34.0	N/A	Gutter 1 Ponding?	N/A
Yes	Refuge 1 Width (In)	71.0	N/A	Gutter 1 Lip Ht (In)	N/A
Yes	Refuge 1 Slope (%)	2.7	N/A	Gutter 1 Slope (%)	N/A
No	Refuge 1 X Slope (%)	9.1	N/A	Gutter 1 X Slope (%)	N/A
N/A	Painted X Walk1?	Yes	N/A	DWS 1 Provided?	N/A
N/A	X Walk 1 Direction	To N	N/A	DWS 1 Contrast?	N/A
N/A	X Walk 1 Width (In)	111.0	N/A	DWS 1 Length (In)	N/A
N/A	Road 1 Slope (%)	6.4	N/A	DWS 1 Full Width?	N/A
N/A	Road 1 X Slope (%)	0.8	N/A	DWS 1 Offset (In)	N/A
No	Refuge 2 Length (In)	34.0	N/A	Gutter 2 Ponding?	N/A
Yes	Refuge 2 Width (In)	71.0	N/A	Gutter 2 Lip Ht (In)	N/A
Yes	Refuge 2 Slope (%)	1.5	N/A	Gutter 2 Slope (%)	N/A
No	Refuge 2 X Slope (%)	6.6	N/A	Gutter 2 X Slope (%)	N/A
N/A	Painted X Walk2?	Yes	N/A	DWS 2 Provided?	N/A
N/A	X Walk 2 Direction	To S	N/A	DWS 2 Contrast?	N/A
N/A	X Walk 2 Width (In)	106.0	N/A	DWS 2 Length (In)	N/A

N/A	Road 2 Slope (%)	5.8	N/A	DWS 2 Full Width?	N/A
N/A	Road 2 X Slope (%)	4.7	N/A	DWS 2 Offset (In)	N/A
N/A	Refuge 3 Length (in)	N/A	N/A	Gutter 3 Ponding?	N/A
N/A	Refuge 3 Width (in)	N/A	N/A	Gutter 3 Lip Ht (in)	N/A
N/A	Refuge 3 Slope (%)	N/A	N/A	Gutter 3 Slope (%)	N/A
N/A	Refuge 3 XSlope (%)	N/A	N/A	Gutter 3 XSlope (%)	N/A
N/A	Painted X Walk3?	N/A	N/A	DWS 3 Provided?	N/A
N/A	X Walk 3 Direction	N/A	N/A	DWS 3 Contrast?	N/A
N/A	X Walk 3 Width (in)	N/A	N/A	DWS 3 Length (in)	N/A
N/A	Road 3 Slope (%)	N/A	N/A	DWS 3 Full Width?	N/A
N/A	Road 3 XSlope (%)	N/A	N/A	DWS 3 Offset (in)	N/A
Yes	Any Obstructions?	N/A	N/A	Storm Grate/Utility Hazard?	N/A
N/A	Obstruction Type		N/A	Storm Grate/Utility Type	
		N/A			N/A
N/A	Surface Condition	Good

**Remove & Replace Entire Refuge.**

Total Cost: \$ 3000.00
