Access Compliance Report

Public Rights-of-Way

(Island Curb Cuts)

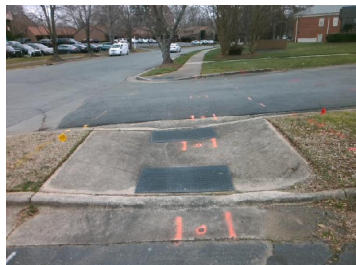
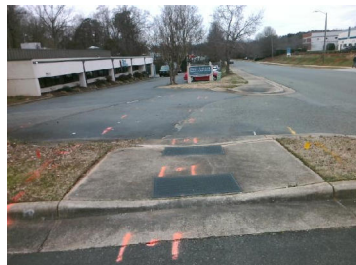
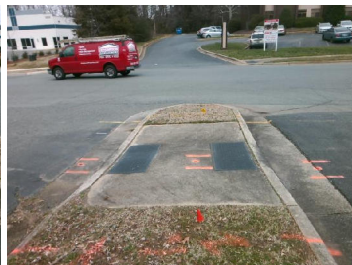
Intersection ID: 10030167	Main Street: LATROBE_DR	Cross Street: N/A	Location: SW
ADA ID: 3958667E23F9	Curb Cut Type: MedianRefuge2	Initial Pass/Fail: Fail	Overall Compliance: No
Codes/Mitigation Info/Possible Solution		Field Measurements/Component Compliance	
Severity Score: 30

Compliance	Description	Data	Compliance	Description	Data
Yes	Refuge 1 Length (In)	49.0	N/A	Gutter 1 Ponding?	N/A
No	Refuge 1 Width (In)	36.0	N/A	Gutter 1 Lip Ht (In)	N/A
Yes	Refuge 1 Slope (%)	1.4	N/A	Gutter 1 Slope (%)	N/A
Yes	Refuge 1 X Slope (%)	0.0	N/A	Gutter 1 X Slope (%)	N/A
N/A	Painted X Walk1?	No	N/A	DWS 1 Provided?	N/A
N/A	X Walk 1 Direction	To SE	N/A	DWS 1 Contrast?	N/A
N/A	X Walk 1 Width (In)	N/A	N/A	DWS 1 Length (In)	N/A
N/A	Road 1 Slope (%)	1.1	N/A	DWS 1 Full Width?	N/A
N/A	Road 1 X Slope (%)	1.4	N/A	DWS 1 Offset (In)	N/A
Yes	Refuge 2 Length (In)	49.0	N/A	Gutter 2 Ponding?	N/A
No	Refuge 2 Width (In)	36.0	N/A	Gutter 2 Lip Ht (In)	N/A
No	Refuge 2 Slope (%)	6.9	N/A	Gutter 2 Slope (%)	N/A
Yes	Refuge 2 X Slope (%)	1.3	N/A	Gutter 2 X Slope (%)	N/A
N/A	Painted X Walk2?	No	N/A	DWS 2 Provided?	N/A
N/A	X Walk 2 Direction	To NW	N/A	DWS 2 Contrast?	N/A
N/A	X Walk 2 Width (In)	N/A	N/A	DWS 2 Length (In)	N/A

Possible Solutions:

Remove & Replace Entire Refuge.
