Access Compliance Report

Public Rights-of-Way

(Island Curb Cuts)

Intersection ID: 5704	Main Street: W_W_T_HARRIS_BV	Cross Street: N_TRYON_ST	Location: NW
ADA ID: 39AB24D3AFE5	Curb Cut Type: MedianRefuge2	Initial Pass/Fail: Fail	Overall Compliance: No
Severity Score: 1.25			
Codes/Mitigation Info/Possible Solution		Field Measurements/Component Compliance

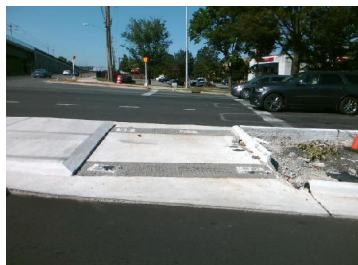
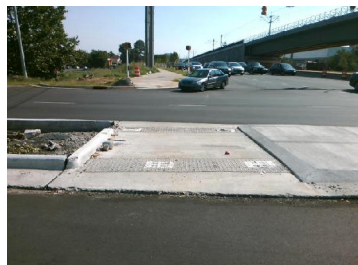
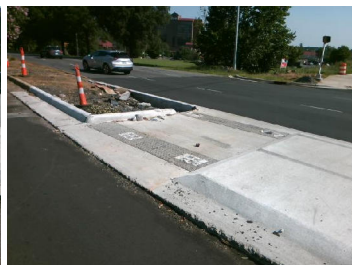
Compliance	Description	Data	Compliance	Description	Data
Yes	Refuge 1 Length (In)	70.0	N/A	Gutter 1 Ponding?	N/A
Yes	Refuge 1 Width (In)	118.0	N/A	Gutter 1 Lip Ht (In)	N/A
Yes	Refuge 1 Slope (%)	3.8	N/A	Gutter 1 Slope (%)	N/A
Yes	Refuge 1 X Slope (%)	2.0	N/A	Gutter 1 X Slope (%)	N/A
N/A	Painted X Walk1?	No	N/A	DWS 1 Provided?	N/A
N/A	X Walk 1 Direction	To NE	N/A	DWS 1 Contrast?	N/A
N/A	X Walk 1 Width (In)	N/A	N/A	DWS 1 Length (In)	N/A
N/A	Road 1 Slope (%)	2.9	N/A	DWS 1 Full Width?	N/A
N/A	Road 1 X Slope (%)	1.9	N/A	DWS 1 Offset (In)	N/A
Yes	Refuge 2 Length (In)	70.0	N/A	Gutter 2 Ponding?	N/A
Yes	Refuge 2 Width (In)	118.0	N/A	Gutter 2 Lip Ht (In)	N/A
Yes	Refuge 2 Slope (%)	3.4	N/A	Gutter 2 Slope (%)	N/A
Yes	Refuge 2 X Slope (%)	3.4	N/A	Gutter 2 X Slope (%)	N/A
N/A	Painted X Walk2?	No	N/A	DWS 2 Provided?	N/A
N/A	X Walk 2 Direction	To SW	N/A	DWS 2 Contrast?	N/A
N/A	X Walk 2 Width (In)	N/A	N/A	DWS 2 Length (In)	N/A

N/A	Road 2 Slope (%)	1.9	N/A	DWS 2 Full Width?	N/A
N/A	Road 2 X Slope (%)	1.0	N/A	DWS 2 Offset (In)	N/A
N/A	Refuge 3 Length (in)	N/A	N/A	Gutter 3 Ponding?	N/A
N/A	Refuge 3 Width (in)	N/A	N/A	Gutter 3 Lip Ht (in)	N/A
N/A	Refuge 3 Slope (%)	N/A	N/A	Gutter 3 Slope (%)	N/A
N/A	Refuge 3 XSlope (%)	N/A	N/A	Gutter 3 XSlope (%)	N/A
N/A	Painted X Walk3?	No	N/A	DWS 3 Provided?	N/A
N/A	X Walk 3 Direction	N/A	N/A	DWS 3 Contrast?	N/A
N/A	X Walk 3 Width (in)	N/A	N/A	DWS 3 Length (in)	N/A
N/A	Road 3 Slope (%)	N/A	N/A	DWS 3 Full Width?	N/A
N/A	Road 3 XSlope (%)	N/A	N/A	DWS 3 Offset (in)	N/A
Yes	Any Obstructions?	N/A	N/A	Storm Grate/Utility Hazard?	N/A
N/A	Obstruction Type		N/A	Storm Grate/Utility Type	
		N/A			N/A
N/A	Surface Condition	Good

Remove & Replace Entire Refuge.
