Access Compliance Report

Public Rights-of-Way

(Island Curb Cuts)

Intersection ID: 30548	Main Street: SOUTH_BV	Cross Street: N/A	Location: E
ADA ID: 3B139A9EC52F	Curb Cut Type: MedianRefuge2	Initial Pass/Fail: Fail	Overall Compliance: No
Codes/Mitigation Info/Possible Solution		Field Measurements/Component Compliance

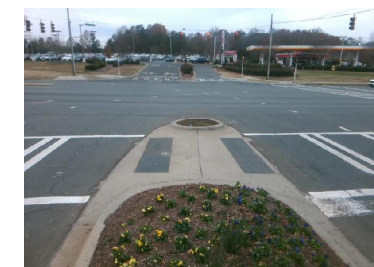
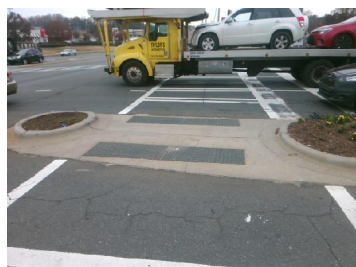
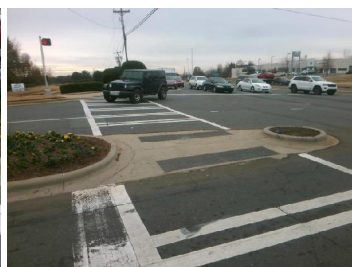
Compliance	Description	Data	Compliance	Description	Data
Yes	Refuge 1 Length (In)	52.5	N/A	Gutter 1 Ponding?	N/A
Yes	Refuge 1 Width (In)	141.0	N/A	Gutter 1 Lip Ht (In)	N/A
Yes	Refuge 1 Slope (%)	2.7	N/A	Gutter 1 Slope (%)	N/A
Yes	Refuge 1 X Slope (%)	2.6	N/A	Gutter 1 X Slope (%)	N/A
N/A	Painted X Walk1?	Yes	N/A	DWS 1 Provided?	N/A
N/A	X Walk 1 Direction	To SE	N/A	DWS 1 Contrast?	N/A
N/A	X Walk 1 Width (In)	133.0	N/A	DWS 1 Length (In)	N/A
N/A	Road 1 Slope (%)	1.9	N/A	DWS 1 Full Width?	N/A
N/A	Road 1 X Slope (%)	2.8	N/A	DWS 1 Offset (In)	N/A
Yes	Refuge 2 Length (In)	52.5	N/A	Gutter 2 Ponding?	N/A
Yes	Refuge 2 Width (In)	141.0	N/A	Gutter 2 Lip Ht (In)	N/A
Yes	Refuge 2 Slope (%)	3.4	N/A	Gutter 2 Slope (%)	N/A
Yes	Refuge 2 X Slope (%)	1.7	N/A	Gutter 2 X Slope (%)	N/A
N/A	Painted X Walk2?	Yes	N/A	DWS 2 Provided?	N/A
N/A	X Walk 2 Direction	To NW	N/A	DWS 2 Contrast?	N/A
N/A	X Walk 2 Width (In)	135.0	N/A	DWS 2 Length (In)	N/A

N/A	Road 2 Slope (%)	2.0	N/A	DWS 2 Full Width?	N/A
N/A	Road 2 X Slope (%)	2.8	N/A	DWS 2 Offset (In)	N/A
N/A	Refuge 3 Length (in)	N/A	N/A	Gutter 3 Ponding?	N/A
N/A	Refuge 3 Width (in)	N/A	N/A	Gutter 3 Lip Ht (in)	N/A
N/A	Refuge 3 Slope (%)	N/A	N/A	Gutter 3 Slope (%)	N/A
N/A	Refuge 3 XSlope (%)	N/A	N/A	Gutter 3 XSlope (%)	N/A
N/A	Painted X Walk3?	N/A	N/A	DWS 3 Provided?	N/A
N/A	X Walk 3 Direction	N/A	N/A	DWS 3 Contrast?	N/A
N/A	X Walk 3 Width (in)	N/A	N/A	DWS 3 Length (in)	N/A
N/A	Road 3 Slope (%)	N/A	N/A	DWS 3 Full Width?	N/A
N/A	Road 3 XSlope (%)	N/A	N/A	DWS 3 Offset (in)	N/A
Yes	Any Obstructions?	N/A	N/A	Storm Grate/Utility Hazard?	N/A
N/A	Obstruction Type		N/A	Storm Grate/Utility Type	
		N/A			N/A
N/A	Surface Condition	Good

Remove & Replace Entire Refuge.
