Access Compliance Report

Public Rights-of-Way

(Island Curb Cuts)

Intersection ID: 23966	Main Street: CAROLINA_PAVILION_DR_N	Cross Street: SOUTH_BV	Location: E
ADA ID: 3C486D8B95EF	Curb Cut Type: MedianRefuge2	Initial Pass/Fail: Fail	Overall Compliance: No
Severity Score: 1.25			
Codes/Mitigation Info/Possible Solution		Field Measurements/Component Compliance

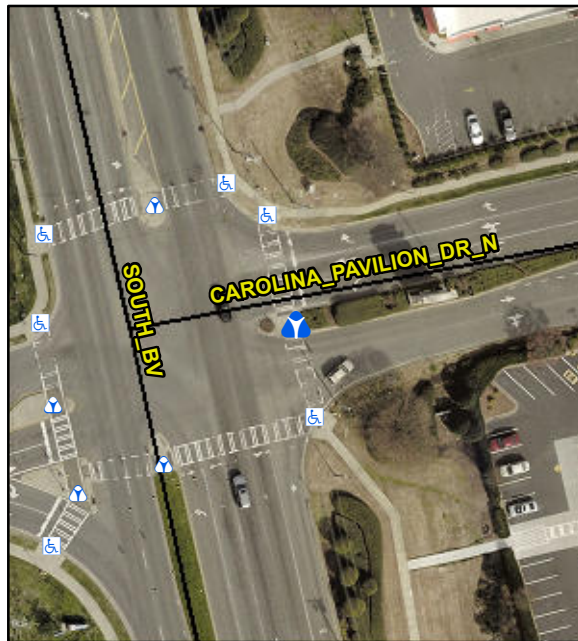
Compliance	Description	Data	Compliance	Description	Data
Yes	Refuge 1 Length (In)	84.5	N/A	Gutter 1 Ponding?	N/A
Yes	Refuge 1 Width (In)	131.0	N/A	Gutter 1 Lip Ht (In)	N/A
Yes	Refuge 1 Slope (%)	1.1	N/A	Gutter 1 Slope (%)	N/A
Yes	Refuge 1 X Slope (%)	2.8	N/A	Gutter 1 X Slope (%)	N/A
N/A	Painted X Walk1?	Yes	N/A	DWS 1 Provided?	N/A
N/A	X Walk 1 Direction	To S	N/A	DWS 1 Contrast?	N/A
N/A	X Walk 1 Width (In)	107.0	N/A	DWS 1 Length (In)	N/A
N/A	Road 1 Slope (%)	2.0	N/A	DWS 1 Full Width?	N/A
N/A	Road 1 X Slope (%)	0.4	N/A	DWS 1 Offset (In)	N/A
Yes	Refuge 2 Length (In)	84.5	N/A	Gutter 2 Ponding?	N/A
Yes	Refuge 2 Width (In)	131.0	N/A	Gutter 2 Lip Ht (In)	N/A
Yes	Refuge 2 Slope (%)	3.0	N/A	Gutter 2 Slope (%)	N/A
Yes	Refuge 2 X Slope (%)	1.9	N/A	Gutter 2 X Slope (%)	N/A
N/A	Painted X Walk2?	Yes	N/A	DWS 2 Provided?	N/A
N/A	X Walk 2 Direction	To N	N/A	DWS 2 Contrast?	N/A
N/A	X Walk 2 Width (In)	108.0	N/A	DWS 2 Length (In)	N/A

N/A	Road 2 Slope (%)	2.9	N/A	DWS 2 Full Width?	N/A
N/A	Road 2 X Slope (%)	0.9	N/A	DWS 2 Offset (In)	N/A
N/A	Refuge 3 Length (in)	N/A	N/A	Gutter 3 Ponding?	N/A
N/A	Refuge 3 Width (in)	N/A	N/A	Gutter 3 Lip Ht (in)	N/A
N/A	Refuge 3 Slope (%)	N/A	N/A	Gutter 3 Slope (%)	N/A
N/A	Refuge 3 XSlope (%)	N/A	N/A	Gutter 3 XSlope (%)	N/A
N/A	Painted X Walk3?	N/A	N/A	DWS 3 Provided?	N/A
N/A	X Walk 3 Direction	N/A	N/A	DWS 3 Contrast?	N/A
N/A	X Walk 3 Width (in)	N/A	N/A	DWS 3 Length (in)	N/A
N/A	Road 3 Slope (%)	N/A	N/A	DWS 3 Full Width?	N/A
N/A	Road 3 XSlope (%)	N/A	N/A	DWS 3 Offset (in)	N/A
Yes	Any Obstructions?	N/A	N/A	Storm Grate/Utility Hazard?	N/A
N/A	Obstruction Type		N/A	Storm Grate/Utility Type	
		N/A			N/A
N/A	Surface Condition	Good

Possible Solutions:

Remove & Replace Entire Refuge.
