# Access Compliance Report

## Public Rights-of-Way

### (Island Curb Cuts)

Intersection ID: 47099	Main Street: GALLERIA_BV	Cross Street: N/A	Location: S
ADA ID: 3CC0A1A41E1C	Curb Cut Type: MedianRefuge2	Initial Pass/Fail: Fail	Overall Compliance: No
Codes/Mitigation Info/Possible Solution		Field Measurements/Component Compliance

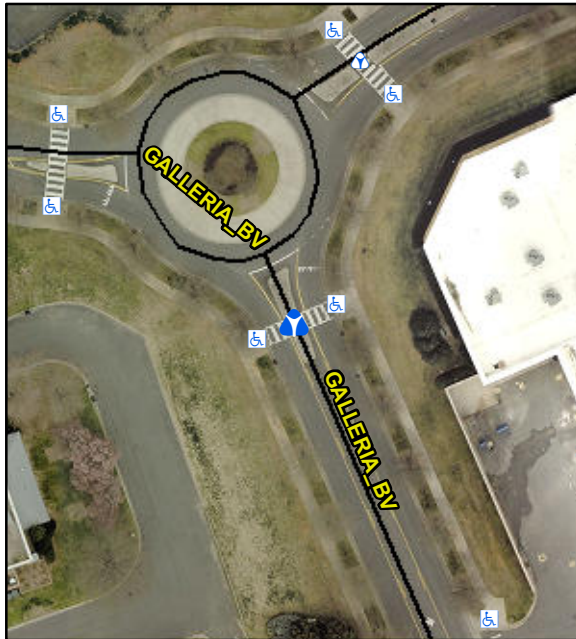
Compliance	Description	Data	Compliance	Description	Data
Yes	Refuge 1 Length (In)	98.0	N/A	Gutter 1 Ponding?	N/A
No	Refuge 1 Width (In)	59.0	N/A	Gutter 1 Lip Ht (In)	N/A
No	Refuge 1 Slope (%)	8.6	N/A	Gutter 1 Slope (%)	N/A
Yes	Refuge 1 X Slope (%)	4.8	N/A	Gutter 1 X Slope (%)	N/A
N/A	Painted X Walk1?	Yes	N/A	DWS 1 Provided?	N/A
N/A	X Walk 1 Direction	To W	N/A	DWS 1 Contrast?	N/A
N/A	X Walk 1 Width (In)	98.0	N/A	DWS 1 Length (In)	N/A
N/A	Road 1 Slope (%)	0.1	N/A	DWS 1 Full Width?	N/A
N/A	Road 1 X Slope (%)	2.1	N/A	DWS 1 Offset (In)	N/A
Yes	Refuge 2 Length (In)	98.0	N/A	Gutter 2 Ponding?	N/A
No	Refuge 2 Width (In)	59.0	N/A	Gutter 2 Lip Ht (In)	N/A
Yes	Refuge 2 Slope (%)	4.2	N/A	Gutter 2 Slope (%)	N/A
Yes	Refuge 2 X Slope (%)	0.6	N/A	Gutter 2 X Slope (%)	N/A
N/A	Painted X Walk2?	Yes	N/A	DWS 2 Provided?	N/A
N/A	X Walk 2 Direction	To E	N/A	DWS 2 Contrast?	N/A
N/A	X Walk 2 Width (In)	98.0	N/A	DWS 2 Length (In)	N/A

**Remove & Replace Entire Refuge.**

Total Cost: \$ 3000.00

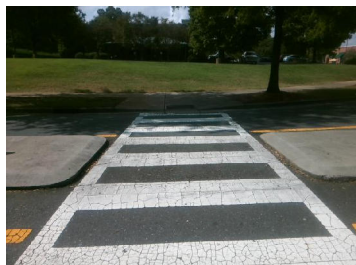
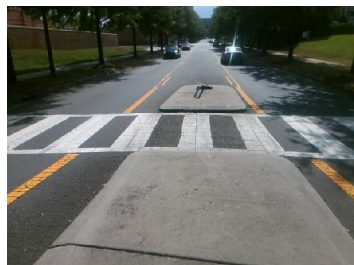
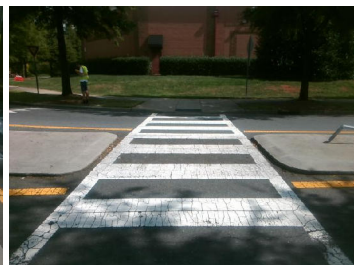
N/A	Road 2 Slope (%)	0.7	N/A	DWS 2 Full Width?	N/A
N/A	Road 2 X Slope (%)	1.1	N/A	DWS 2 Offset (In)	N/A
N/A	Refuge 3 Length (in)	N/A	N/A	Gutter 3 Ponding?	N/A
N/A	Refuge 3 Width (in)	N/A	N/A	Gutter 3 Lip Ht (in)	N/A
N/A	Refuge 3 Slope (%)	N/A	N/A	Gutter 3 Slope (%)	N/A
N/A	Refuge 3 XSlope (%)	N/A	N/A	Gutter 3 XSlope (%)	N/A
N/A	Painted X Walk3?	N/A	N/A	DWS 3 Provided?	N/A
N/A	X Walk 3 Direction	N/A	N/A	DWS 3 Contrast?	N/A
N/A	X Walk 3 Width (in)	N/A	N/A	DWS 3 Length (in)	N/A
N/A	Road 3 Slope (%)	N/A	N/A	DWS 3 Full Width?	N/A
N/A	Road 3 XSlope (%)	N/A	N/A	DWS 3 Offset (in)	N/A
Yes	Any Obstructions?	N/A	N/A	Storm Grate/Utility Hazard?	N/A
N/A	Obstruction Type		N/A	Storm Grate/Utility Type	
		N/A			N/A
N/A	Surface Condition	Good
