Access Compliance Report

Public Rights-of-Way

(Island Curb Cuts)

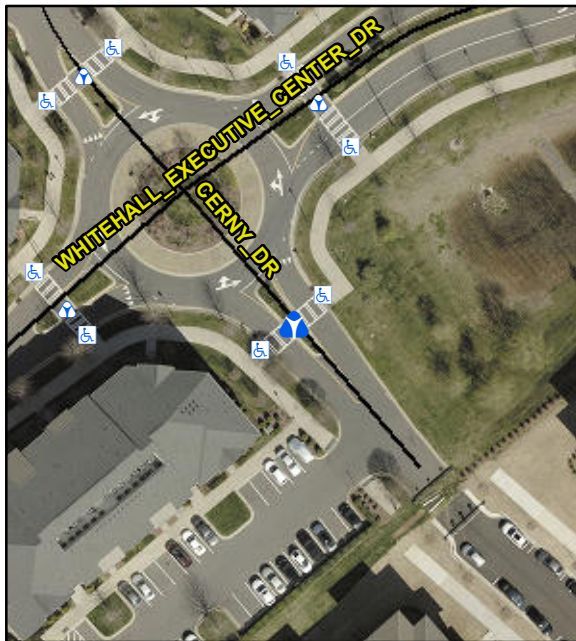
Intersection ID: 52476	Main Street: WHITEHALL_EXECUTIVE_CENTER_DR	Cross Street: CERNY_DR	Location: SE
ADA ID: 3D8C0772709D	Curb Cut Type: MedianRefuge2	Initial Pass/Fail: Fail	Overall Compliance: No
Codes/Mitigation Info/Possible Solution		Field Measurements/Component Compliance

Compliance	Description	Data	Compliance	Description	Data
Yes	Refuge 1 Length (In)	45.0	N/A	Gutter 1 Ponding?	N/A
Yes	Refuge 1 Width (In)	95.0	N/A	Gutter 1 Lip Ht (In)	N/A
Yes	Refuge 1 Slope (%)	2.1	N/A	Gutter 1 Slope (%)	N/A
Yes	Refuge 1 X Slope (%)	2.7	N/A	Gutter 1 X Slope (%)	N/A
N/A	Painted X Walk1?	Yes	N/A	DWS 1 Provided?	N/A
N/A	X Walk 1 Direction	To SW	N/A	DWS 1 Contrast?	N/A
N/A	X Walk 1 Width (In)	111.0	N/A	DWS 1 Length (In)	N/A
N/A	Road 1 Slope (%)	0.0	N/A	DWS 1 Full Width?	N/A
N/A	Road 1 X Slope (%)	0.3	N/A	DWS 1 Offset (In)	N/A
Yes	Refuge 2 Length (In)	45.0	N/A	Gutter 2 Ponding?	N/A
Yes	Refuge 2 Width (In)	95.0	N/A	Gutter 2 Lip Ht (In)	N/A
Yes	Refuge 2 Slope (%)	0.9	N/A	Gutter 2 Slope (%)	N/A
Yes	Refuge 2 X Slope (%)	1.4	N/A	Gutter 2 X Slope (%)	N/A
N/A	Painted X Walk2?	Yes	N/A	DWS 2 Provided?	N/A
N/A	X Walk 2 Direction	To NE	N/A	DWS 2 Contrast?	N/A
N/A	X Walk 2 Width (In)	112.0	N/A	DWS 2 Length (In)	N/A

N/A	Road 2 Slope (%)	0.3	N/A	DWS 2 Full Width?	N/A
N/A	Road 2 X Slope (%)	3.6	N/A	DWS 2 Offset (In)	N/A
N/A	Refuge 3 Length (in)	N/A	N/A	Gutter 3 Ponding?	N/A
N/A	Refuge 3 Width (in)	N/A	N/A	Gutter 3 Lip Ht (in)	N/A
N/A	Refuge 3 Slope (%)	N/A	N/A	Gutter 3 Slope (%)	N/A
N/A	Refuge 3 XSlope (%)	N/A	N/A	Gutter 3 XSlope (%)	N/A
N/A	Painted X Walk3?	N/A	N/A	DWS 3 Provided?	N/A
N/A	X Walk 3 Direction	N/A	N/A	DWS 3 Contrast?	N/A
N/A	X Walk 3 Width (in)	N/A	N/A	DWS 3 Length (in)	N/A
N/A	Road 3 Slope (%)	N/A	N/A	DWS 3 Full Width?	N/A
N/A	Road 3 XSlope (%)	N/A	N/A	DWS 3 Offset (in)	N/A
Yes	Any Obstructions?	N/A	N/A	Storm Grate/Utility Hazard?	N/A
N/A	Obstruction Type		N/A	Storm Grate/Utility Type	
		N/A			N/A
N/A	Surface Condition	Good

Possible Solutions:

Remove & Replace Entire Refuge.

Total Cost: \$ 3000.00
