# Access Compliance Report

## Public Rights-of-Way

### (Island Curb Cuts)

| Intersection ID: 51704 | Main Street: IKEA_BV | Cross Street: N/A | Location: | N |

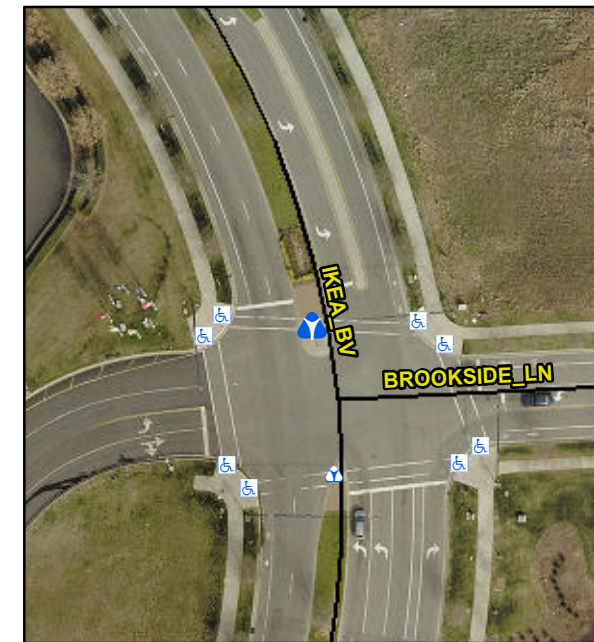
| ADA ID: 3F16F94B0E52 | Curb Cut Type: MedianRefuge2 | Initial Pass/Fail: Fail | Overall Compliance: No | Severity Score: 10 |

| Compliance | Description | Data | Compliance | Description | Data |
|---|---|---|---|---|---|
| No | Refuge 1 Width (In) | 59.0 | N/A | Gutter 1 Lip Ht (In) | N/A |
| No | Refuge 2 Width (In) | 59.0 | N/A | Gutter 2 Lip Ht (In) | N/A |

**Remove & Replace Entire Refuge.**

**\$ 3000.00**
