Access Compliance Report

Public Rights-of-Way

(Island Curb Cuts)

| Intersection ID: 10013227 | Main Street: THE_PLAZA | Cross Street: N/A | Location: N |

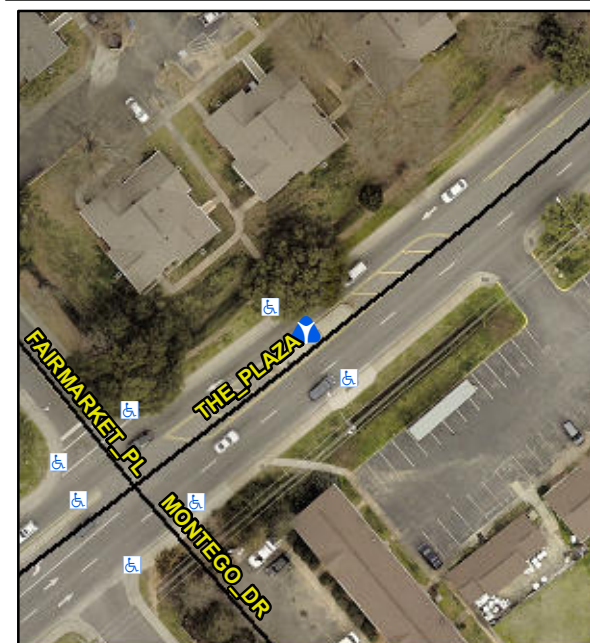
| ADA ID: 40A5CBB23401 | Curb Cut Type: MedianRefuge2 | Initial Pass/Fail: Pass | Overall Compliance: Yes |
| Severity Score: 0 | | | |

N/A

| Compliance | Description | Data | Compliance | Description | Data |
|---|---|---|---|---|---|
| N/A | Surface Condition | Good | N/A | | N/A |

N/A
