Access Compliance Report

Public Rights-of-Way

(Island Curb Cuts)

Intersection ID: 10770	Main Street: ALICE_AV	Cross Street: TUCKASEEGEE_RD	Location: E
ADA ID: 4115AE6F0631	Curb Cut Type: MedianRefuge2	Initial Pass/Fail: Fail	Overall Compliance: No
Severity Score: 1.25			
Codes/Mitigation Info/Possible Solution		Field Measurements/Component Compliance

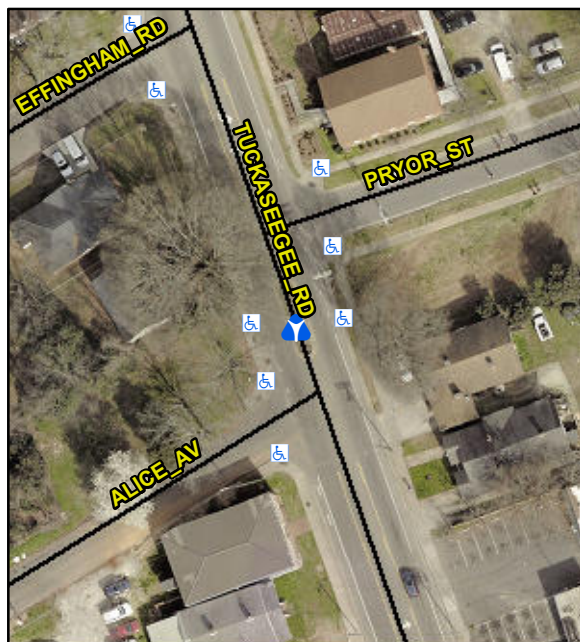
Compliance	Description	Data	Compliance	Description	Data
Yes	Refuge 1 Length (In)	62.5	N/A	Gutter 1 Ponding?	N/A
Yes	Refuge 1 Width (In)	127.0	N/A	Gutter 1 Lip Ht (In)	N/A
Yes	Refuge 1 Slope (%)	2.5	N/A	Gutter 1 Slope (%)	N/A
Yes	Refuge 1 X Slope (%)	1.1	N/A	Gutter 1 X Slope (%)	N/A
N/A	Painted X Walk1?	No	N/A	DWS 1 Provided?	N/A
N/A	X Walk 1 Direction	To E	N/A	DWS 1 Contrast?	N/A
N/A	X Walk 1 Width (In)	N/A	N/A	DWS 1 Length (In)	N/A
N/A	Road 1 Slope (%)	0.3	N/A	DWS 1 Full Width?	N/A
N/A	Road 1 X Slope (%)	4.3	N/A	DWS 1 Offset (In)	N/A
Yes	Refuge 2 Length (In)	62.5	N/A	Gutter 2 Ponding?	N/A
Yes	Refuge 2 Width (In)	127.0	N/A	Gutter 2 Lip Ht (In)	N/A
Yes	Refuge 2 Slope (%)	4.3	N/A	Gutter 2 Slope (%)	N/A
Yes	Refuge 2 X Slope (%)	2.2	N/A	Gutter 2 X Slope (%)	N/A
N/A	Painted X Walk2?	No	N/A	DWS 2 Provided?	N/A
N/A	X Walk 2 Direction	To W	N/A	DWS 2 Contrast?	N/A
N/A	X Walk 2 Width (In)	N/A	N/A	DWS 2 Length (In)	N/A

Remove & Replace Entire Refuge.
