Access Compliance Report

Public Rights-of-Way

(Island Curb Cuts)

Intersection ID: 14547	Main Street: EAST_BV	Cross Street: SPRINGDALE_AV	Location: NW
ADA ID: 416CC5095D1B	Curb Cut Type: MedianRefuge2	Initial Pass/Fail: Fail	Overall Compliance: No
Severity Score: 1.25			
Codes/Mitigation Info/Possible Solution		Field Measurements/Component Compliance

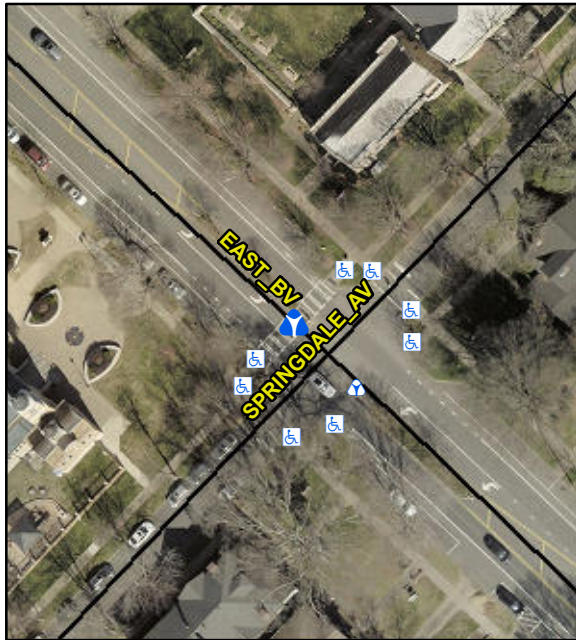
Compliance	Description	Data	Compliance	Description	Data
Yes	Refuge 1 Length (In)	38.25	N/A	Gutter 1 Ponding?	N/A
Yes	Refuge 1 Width (In)	98.0	N/A	Gutter 1 Lip Ht (In)	N/A
Yes	Refuge 1 Slope (%)	0.6	N/A	Gutter 1 Slope (%)	N/A
Yes	Refuge 1 X Slope (%)	3.9	N/A	Gutter 1 X Slope (%)	N/A
N/A	Painted X Walk1?	Yes	N/A	DWS 1 Provided?	N/A
N/A	X Walk 1 Direction	To SW	N/A	DWS 1 Contrast?	N/A
N/A	X Walk 1 Width (In)	112.0	N/A	DWS 1 Length (In)	N/A
N/A	Road 1 Slope (%)	2.7	N/A	DWS 1 Full Width?	N/A
N/A	Road 1 X Slope (%)	0.2	N/A	DWS 1 Offset (In)	N/A
Yes	Refuge 2 Length (In)	38.25	N/A	Gutter 2 Ponding?	N/A
Yes	Refuge 2 Width (In)	98.0	N/A	Gutter 2 Lip Ht (In)	N/A
Yes	Refuge 2 Slope (%)	3.3	N/A	Gutter 2 Slope (%)	N/A
Yes	Refuge 2 X Slope (%)	1.6	N/A	Gutter 2 X Slope (%)	N/A
N/A	Painted X Walk2?	Yes	N/A	DWS 2 Provided?	N/A
N/A	X Walk 2 Direction	To NE	N/A	DWS 2 Contrast?	N/A
N/A	X Walk 2 Width (In)	110.0	N/A	DWS 2 Length (In)	N/A

N/A	Road 2 Slope (%)	2.6	N/A	DWS 2 Full Width?	N/A
N/A	Road 2 X Slope (%)	2.9	N/A	DWS 2 Offset (In)	N/A
N/A	Refuge 3 Length (in)	N/A	N/A	Gutter 3 Ponding?	N/A
N/A	Refuge 3 Width (in)	N/A	N/A	Gutter 3 Lip Ht (in)	N/A
N/A	Refuge 3 Slope (%)	N/A	N/A	Gutter 3 Slope (%)	N/A
N/A	Refuge 3 XSlope (%)	N/A	N/A	Gutter 3 XSlope (%)	N/A
N/A	Painted X Walk3?	N/A	N/A	DWS 3 Provided?	N/A
N/A	X Walk 3 Direction	N/A	N/A	DWS 3 Contrast?	N/A
N/A	X Walk 3 Width (in)	N/A	N/A	DWS 3 Length (in)	N/A
N/A	Road 3 Slope (%)	N/A	N/A	DWS 3 Full Width?	N/A
N/A	Road 3 XSlope (%)	N/A	N/A	DWS 3 Offset (in)	N/A
Yes	Any Obstructions?	N/A	N/A	Storm Grate/Utility Hazard?	N/A
N/A	Obstruction Type		N/A	Storm Grate/Utility Type	
		N/A			N/A
N/A	Surface Condition	Good

Remove & Replace Entire Refuge.

Total Cost: \$ 3000.00
