Access Compliance Report

Public Rights-of-Way

(Island Curb Cuts)

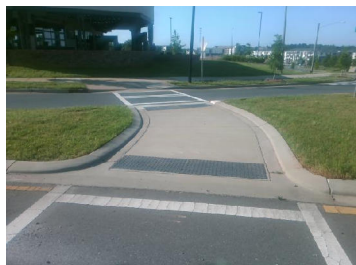
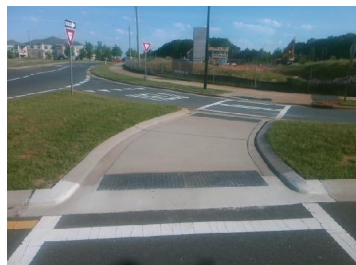
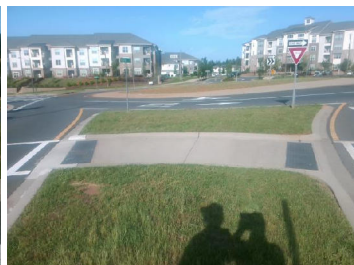
Intersection ID: 53165	Main Street: DIXIE_RIVER_RD	Cross Street: STYLE_LN	Location: E
ADA ID: 417AF7F738B5	Curb Cut Type: MedianRefuge2	Initial Pass/Fail: Fail	Overall Compliance: No
Severity Score: 1.25			
Codes/Mitigation Info/Possible Solution		Field Measurements/Component Compliance

Remove & Replace Entire Refuge.
