Access Compliance Report

Public Rights-of-Way

(Island Curb Cuts)

| Intersection ID: 13985 | Main Street: CAMDEN_RD | Cross Street: EAST_BV | Location: SE |

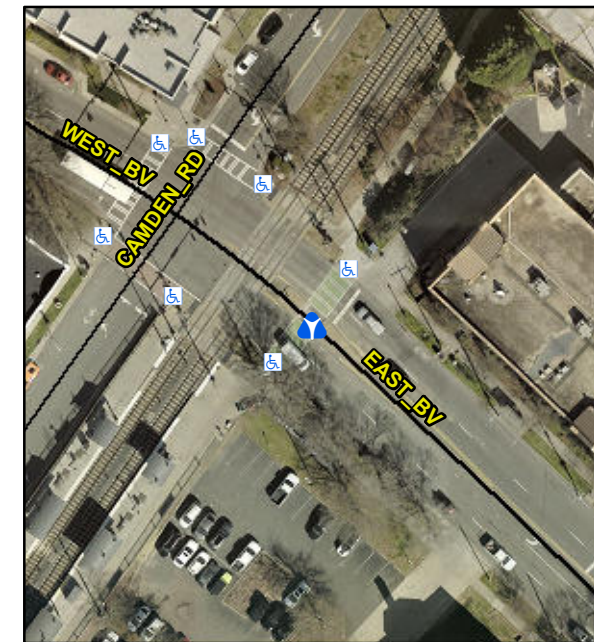
| ADA ID: 41907053C88E | Curb Cut Type: MedianRefuge2 | Initial Pass/Fail: Fail | Overall Compliance: No |

Possible Solutions:

Remove & Replace Entire Refuge.
