Access Compliance Report

Public Rights-of-Way

(Island Curb Cuts)

Intersection ID: 52476	Main Street: WHITEHALL_EXECUTIVE_CENTER_DR	Cross Street: CERNY_DR	Location: SW
ADA ID: 419B725DB8F6	Curb Cut Type: MedianRefuge2	Initial Pass/Fail: Pass	Overall Compliance: No
Codes/Mitigation Info/Possible Solution		Field Measurements/Component Compliance

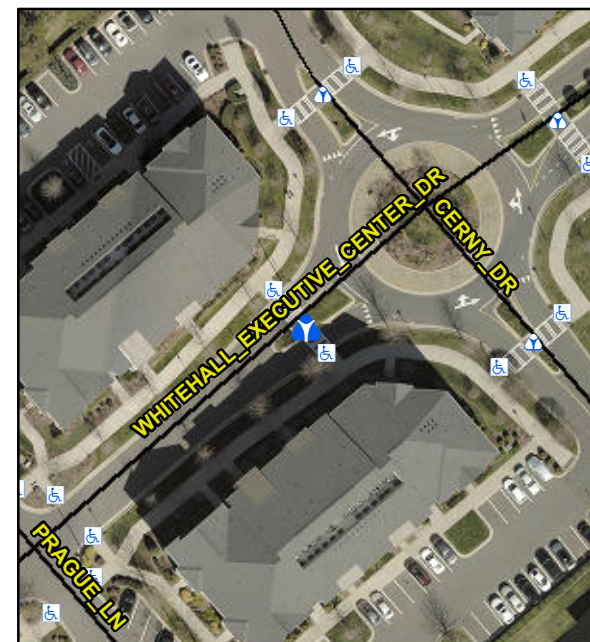
Compliance	Description	Data	Compliance	Description	Data
Yes	Refuge 1 Length (In)	62.0	Yes	Gutter 1 Ponding?	No
Yes	Refuge 1 Width (In)	96.0	Yes	Gutter 1 Lip Ht (In)	0.0
Yes	Refuge 1 Slope (%)	0.6	Yes	Gutter 1 Slope (%)	0.7
Yes	Refuge 1 X Slope (%)	1.6	Yes	Gutter 1 X Slope (%)	0.8
N/A	Painted X Walk1?	Yes	No	DWS 1 Provided?	No
N/A	X Walk 1 Direction	To NW	N/A	DWS 1 Contrast?	No
N/A	X Walk 1 Width (In)	102.5	N/A	DWS 1 Length (In)	N/A
N/A	Road 1 Slope (%)	1.4	N/A	DWS 1 Full Width?	No
N/A	Road 1 X Slope (%)	0.8	N/A	DWS 1 Offset (In)	N/A
Yes	Refuge 2 Length (In)	62.0	Yes	Gutter 2 Ponding?	No
Yes	Refuge 2 Width (In)	96.0	Yes	Gutter 2 Lip Ht (In)	0.0
Yes	Refuge 2 Slope (%)	2.5	Yes	Gutter 2 Slope (%)	3.0
Yes	Refuge 2 X Slope (%)	0.9	Yes	Gutter 2 X Slope (%)	0.3
N/A	Painted X Walk2?	Yes	No	DWS 2 Provided?	No
N/A	X Walk 2 Direction	To SE	N/A	DWS 2 Contrast?	No
N/A	X Walk 2 Width (In)	92.0	N/A	DWS 2 Length (In)	N/A

Possible Solutions:

Install Detectable Warning System.
