Access Compliance Report

Public Rights-of-Way

(Island Curb Cuts)

Intersection ID: 18963	Main Street: GROVER_RD	Cross Street: SOUTH_BV	Location: S
ADA ID: 42565661D0AE	Curb Cut Type: MedianRefuge2	Initial Pass/Fail: Pass	Overall Compliance: No
Severity Score: 15			
Codes/Mitigation Info/Possible Solution		Field Measurements/Component Compliance

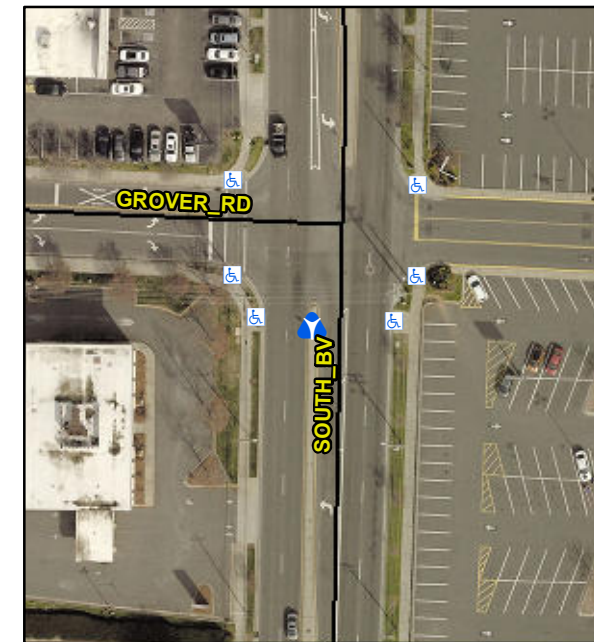
Compliance	Description	Data	Compliance	Description	Data
No	Refuge 1 Length (In)	24.0	Yes	Gutter 1 Ponding?	No
Yes	Refuge 1 Width (In)	96.0	Yes	Gutter 1 Lip Ht (In)	0.0
Yes	Refuge 1 Slope (%)	0.0	Yes	Gutter 1 Slope (%)	3.7
Yes	Refuge 1 X Slope (%)	1.4	Yes	Gutter 1 X Slope (%)	3.5
N/A	Painted X Walk1?	No	No	DWS 1 Provided?	Yes
N/A	X Walk 1 Direction	To W	N/A	DWS 1 Contrast?	Yes
N/A	X Walk 1 Width (In)	N/A	N/A	DWS 1 Length (In)	24.0
N/A	Road 1 Slope (%)	2.8	N/A	DWS 1 Full Width?	Yes
N/A	Road 1 X Slope (%)	4.5	N/A	DWS 1 Offset (In)	12.0
No	Refuge 2 Length (In)	24.0	Yes	Gutter 2 Ponding?	No
Yes	Refuge 2 Width (In)	96.0	Yes	Gutter 2 Lip Ht (In)	0.0
No	Refuge 2 Slope (%)	N/A	Yes	Gutter 2 Slope (%)	3.4
No	Refuge 2 X Slope (%)	N/A	Yes	Gutter 2 X Slope (%)	3.0
N/A	Painted X Walk2?	No	Yes	DWS 2 Provided?	No
N/A	X Walk 2 Direction	To E	N/A	DWS 2 Contrast?	N/A
N/A	X Walk 2 Width (In)	N/A	N/A	DWS 2 Length (In)	N/A
N/A	Road 2 Slope (%)	2.5	N/A	DWS 2 Full Width?	N/A

N/A	Road 2 X Slope (%)	3.0	N/A	DWS 2 Offset (In)	N/A
N/A	Refuge 3 Length (in)	N/A	N/A	Gutter 3 Ponding?	N/A
N/A	Refuge 3 Width (in)	N/A	N/A	Gutter 3 Lip Ht (in)	N/A
N/A	Refuge 3 Slope (%)	N/A	N/A	Gutter 3 Slope (%)	N/A
N/A	Refuge 3 XSlope (%)	N/A	N/A	Gutter 3 XSlope (%)	N/A
N/A	Painted X Walk3?	N/A	N/A	DWS 3 Provided?	N/A
N/A	X Walk 3 Direction	N/A	N/A	DWS 3 Contrast?	N/A
N/A	X Walk 3 Width (in)	N/A	N/A	DWS 3 Length (in)	N/A
N/A	Road 3 Slope (%)	N/A	N/A	DWS 3 Full Width?	N/A
N/A	Road 3 XSlope (%)	N/A	N/A	DWS 3 Offset (in)	N/A
Yes	Any Obstructions?	N/A	N/A	Storm Grate/Utility Hazard?	No
N/A	Obstruction Type		N/A	Storm Grate/Utility Type	
		N/A			N/A
N/A	Surface Condition	Good

Remove & Replace Entire Refuge.

Total Cost: \$ 3000.00
