# Access Compliance Report

## Public Rights-of-Way

### (Island Curb Cuts)

Intersection ID: 12983	Main Street: E_TRADE_ST	Cross Street: N_MYERS_ST	Location: SE
ADA ID: 42E6D48B0B48	Curb Cut Type: MedianRefuge2	Initial Pass/Fail: Fail	Overall Compliance: No
Codes/Mitigation Info/Possible Solution		Field Measurements/Component Compliance

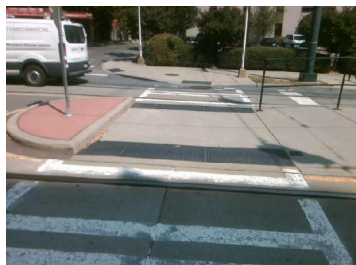
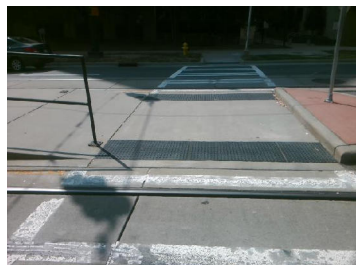
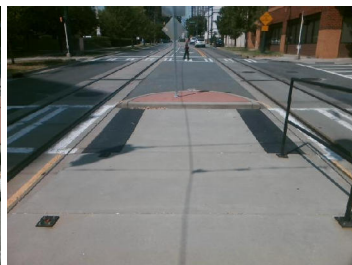
Compliance	Description	Data	Compliance	Description	Data
Yes	Refuge 1 Length (In)	72.0	N/A	Gutter 1 Ponding?	N/A
Yes	Refuge 1 Width (In)	120.0	N/A	Gutter 1 Lip Ht (In)	N/A
Yes	Refuge 1 Slope (%)	3.3	N/A	Gutter 1 Slope (%)	N/A
No	Refuge 1 X Slope (%)	5.8	N/A	Gutter 1 X Slope (%)	N/A
N/A	Painted X Walk1?	Yes	N/A	DWS 1 Provided?	N/A
N/A	X Walk 1 Direction	To SW	N/A	DWS 1 Contrast?	N/A
N/A	X Walk 1 Width (In)	113.0	N/A	DWS 1 Length (In)	N/A
N/A	Road 1 Slope (%)	4.6	N/A	DWS 1 Full Width?	N/A
N/A	Road 1 X Slope (%)	0.2	N/A	DWS 1 Offset (In)	N/A
Yes	Refuge 2 Length (In)	72.0	N/A	Gutter 2 Ponding?	N/A
Yes	Refuge 2 Width (In)	120.0	N/A	Gutter 2 Lip Ht (In)	N/A
Yes	Refuge 2 Slope (%)	0.9	N/A	Gutter 2 Slope (%)	N/A
No	Refuge 2 X Slope (%)	5.2	N/A	Gutter 2 X Slope (%)	N/A
N/A	Painted X Walk2?	Yes	N/A	DWS 2 Provided?	N/A
N/A	X Walk 2 Direction	To NE	N/A	DWS 2 Contrast?	N/A
N/A	X Walk 2 Width (In)	114.0	N/A	DWS 2 Length (In)	N/A

**Remove & Replace Entire Refuge.**
