# Access Compliance Report

## Public Rights-of-Way

### (Island Curb Cuts)

Intersection ID: 10036501	Main Street: ROZZELLES_FERRY_RD	Cross Street: N/A	Location:	N/A
ADA ID: 43EEB23A2A63	Curb Cut Type: MedianRefuge2	Initial Pass/Fail: Fail	Overall Compliance: No	Severity Score: 17.5
Codes/Mitigation Info/Possible Solution		Field Measurements/Component Compliance

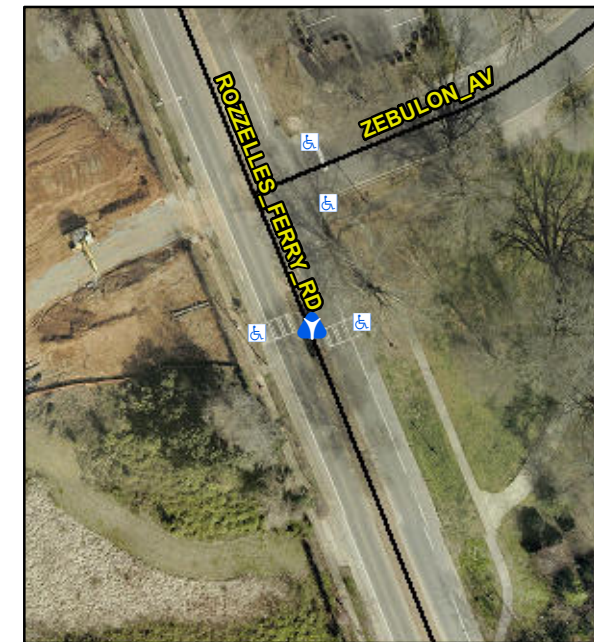
Compliance	Description	Data	Compliance	Description	Data
Yes	Refuge 1 Length (In)	50.0	N/A	Gutter 1 Ponding?	N/A
No	Refuge 1 Width (In)	45.5	N/A	Gutter 1 Lip Ht (In)	N/A
Yes	Refuge 1 Slope (%)	0.8	N/A	Gutter 1 Slope (%)	N/A
Yes	Refuge 1 X Slope (%)	3.3	N/A	Gutter 1 X Slope (%)	N/A
N/A	Painted X Walk1?	Yes	N/A	DWS 1 Provided?	N/A
N/A	X Walk 1 Direction	To E	N/A	DWS 1 Contrast?	N/A
N/A	X Walk 1 Width (In)	110.0	N/A	DWS 1 Length (In)	N/A
N/A	Road 1 Slope (%)	3.0	N/A	DWS 1 Full Width?	N/A
N/A	Road 1 X Slope (%)	1.0	N/A	DWS 1 Offset (In)	N/A
Yes	Refuge 2 Length (In)	50.0	N/A	Gutter 2 Ponding?	N/A
No	Refuge 2 Width (In)	45.5	N/A	Gutter 2 Lip Ht (In)	N/A
Yes	Refuge 2 Slope (%)	1.6	N/A	Gutter 2 Slope (%)	N/A
Yes	Refuge 2 X Slope (%)	2.9	N/A	Gutter 2 X Slope (%)	N/A
N/A	Painted X Walk2?	Yes	N/A	DWS 2 Provided?	N/A
N/A	X Walk 2 Direction	To W	N/A	DWS 2 Contrast?	N/A
N/A	X Walk 2 Width (In)	109.0	N/A	DWS 2 Length (In)	N/A

N/A	Road 2 Slope (%)	2.8	N/A	DWS 2 Full Width?	N/A
N/A	Road 2 X Slope (%)	3.8	N/A	DWS 2 Offset (In)	N/A
N/A	Refuge 3 Length (in)	N/A	N/A	Gutter 3 Ponding?	N/A
N/A	Refuge 3 Width (in)	N/A	N/A	Gutter 3 Lip Ht (in)	N/A
N/A	Refuge 3 Slope (%)	N/A	N/A	Gutter 3 Slope (%)	N/A
N/A	Refuge 3 XSlope (%)	N/A	N/A	Gutter 3 XSlope (%)	N/A
N/A	Painted X Walk3?	N/A	N/A	DWS 3 Provided?	N/A
N/A	X Walk 3 Direction	N/A	N/A	DWS 3 Contrast?	N/A
N/A	X Walk 3 Width (in)	N/A	N/A	DWS 3 Length (in)	N/A
N/A	Road 3 Slope (%)	N/A	N/A	DWS 3 Full Width?	N/A
N/A	Road 3 XSlope (%)	N/A	N/A	DWS 3 Offset (in)	N/A
Yes	Any Obstructions?	N/A	N/A	Storm Grate/Utility Hazard?	N/A
N/A	Obstruction Type		N/A	Storm Grate/Utility Type	
		N/A			N/A
N/A	Surface Condition	Good

**Remove & Replace Entire Refuge.**

Total Cost: \$ 3000.00
